Expertise

Protocol number: 41830063
Order number / reference: 25283749
Inspection date: 6 Oct 2025

Manufacturer: Mercedes-Benz	Model: Vito 114 CDI Kompakt HA Aut. BASE
VIN: W1V44760114123584

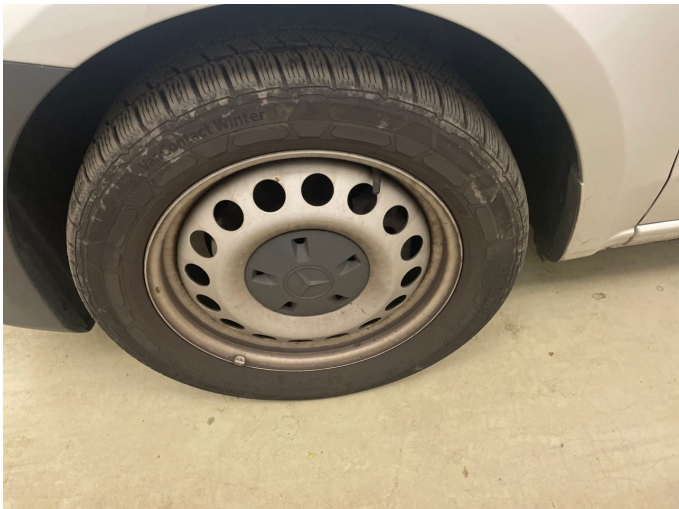
Figure 12: Mounted tyres

#	Tyre size	Type of tyre	Manufacturer	Tread depth
1)	225/55 R17 107T	All-season tyres on Steel	Continental	5mm / 5mm
2)	225/55 R17 107T	All-season tyres on Steel	Continental	5mm / 5mm
