Expertise

Protocol number: 41492134
Order No. / Reference: 25188403
Inspection date: 10 Sept 2025

Manufacturer: Mercedes-Benz

Model: Vito 114 CDI Kompakt HA Aut. BASE

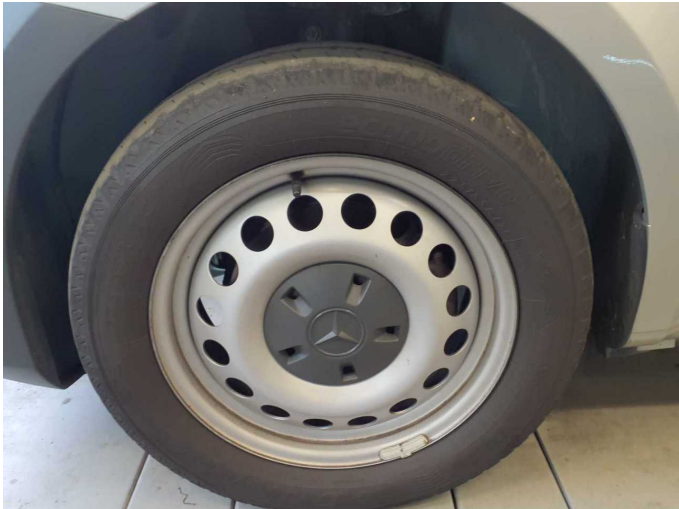
Figure 12: Mounted tyres

- Für den montierten Radsatz wurde kein Nachweiß erbracht.
- Sommerradsatz ist kein Bestandteil des Auslieferungsumfangs.
