Expertise

Protocol number: 41530908  
Order No. / Reference: 25177463  
Inspection date: 15 Sept 2025

Manufacturer: Mercedes-Benz  
VIN: W1V44760314134448

Model: Vito 114 CDI Lang HA Aut. PRO

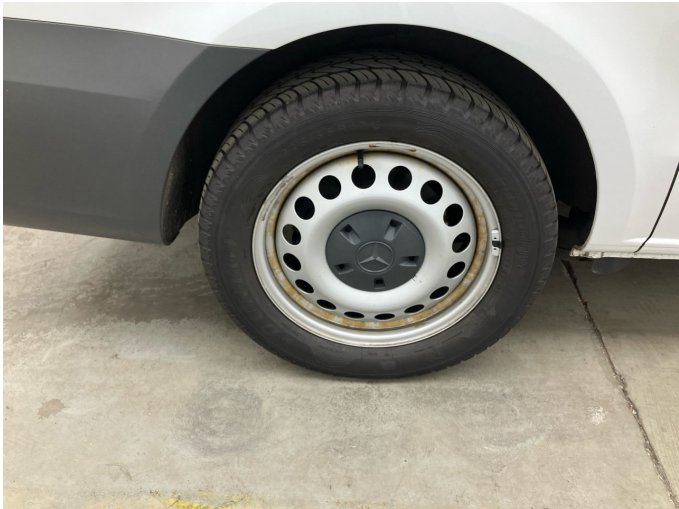
Figure 12: Mounted tyres

- Für den montierten Radsatz wurde kein Nachweiß erbracht.
- Sommerradsatz ist kein Bestandteil des Auslieferungsumfangs.
