Expertise

Protocol number: 41735863
Order number / reference: 25251863
Inspection date: 26 Sept 2025

Model: Vito 114 CDI Lang HA Aut. PRO

VIN: W1V44760314136041

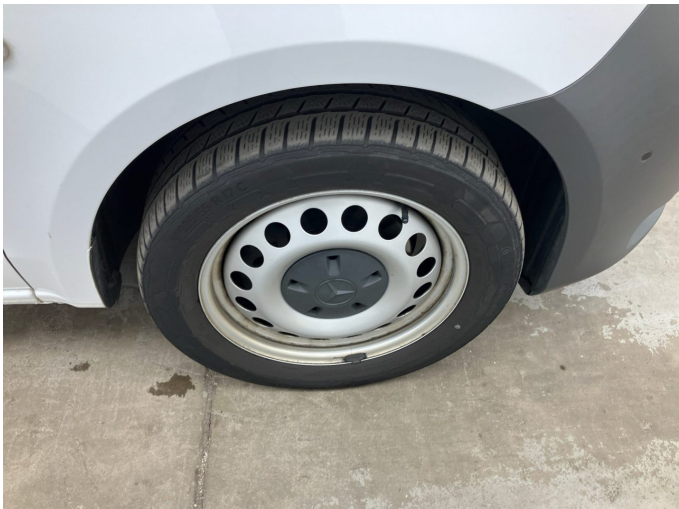
Figure 12: Mounted tyres

#	Tyre size	Type of tyre	Manufacturer	Tread depth
1)	225/55 R17 104T	Winter tyres on Steel rim with wheel cover	Continental	5mm / 5mm
2)	225/55 R17 104T	Winter tyres on Steel rim with wheel cover	Continental	5mm / 5mm

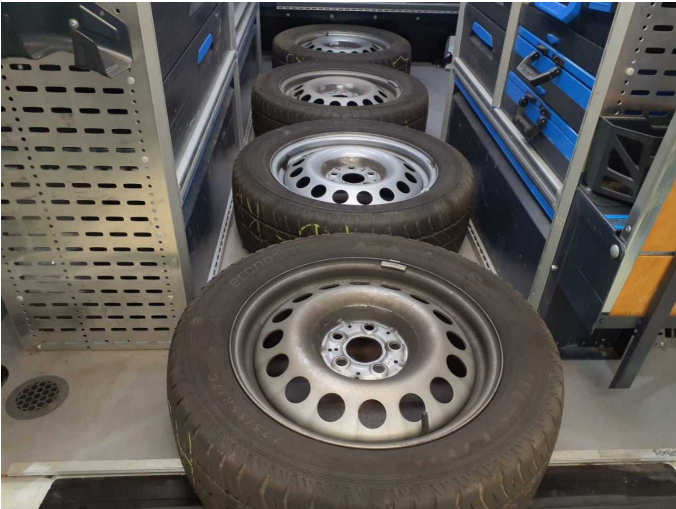
Figure 15: Additional tyres

#	Tyre size	Type of tyre	Manufacturer	Tread depth
1)	225/55 R17 109H	Summer tyres on Steel	Dunlop	6mm / 6mm
2)	225/55 R17 109H	Summer tyres on Steel	Dunlop	6mm / 6mm
