Expertise

Protocol number: 41593647
Order No. / Reference: 25139980
Inspection date: 17 Sept 2025

Manufacturer: Mercedes-Benz
VIN: W1V44760513978638

Model: Vito 116 CDI Kasten Extralang HA PRO

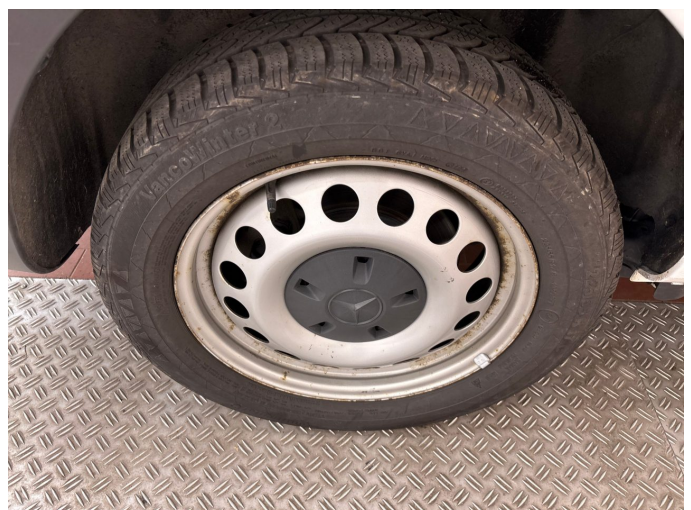
Figure 12: Mounted tyres

#	Tyre size	Type of tyre	Manufacturer	Tread depth
1)	225/55 R17 109T	Winter tyres on Steel rim with wheel cover	Continental	2mm / 2mm
2)	225/55 R17 109T	Winter tyres on Steel rim with wheel cover	Continental	5mm / 5mm
