## status report

#### Audi A6 Avant 2.0 TDI quattro

| Vehicle identification number | <b>WAUZZZ4G5JN118183</b> | mileage read: | <b>173940 km</b> |

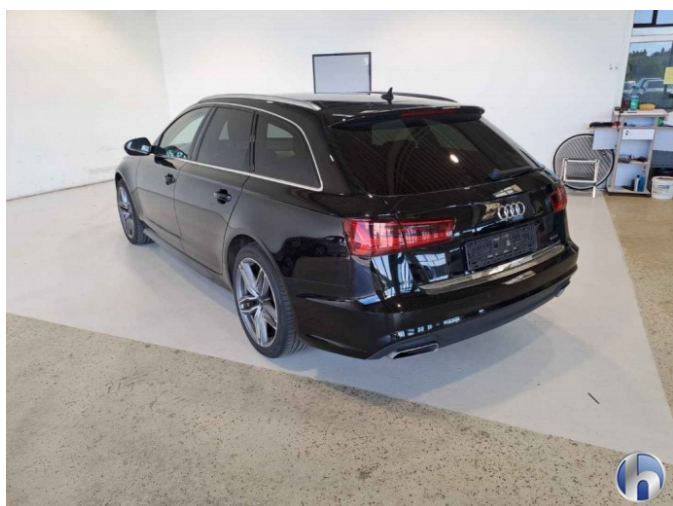
rear Left

| | <b>component</b> | <b>Damage</b> | <b>Rep kind</b> |
|---|---|---|---|
| 7. | Sidewall - Rear - Left | Delle | Smart repair |
| 9. | Rear door - left | Scrape | Smart repair |
| 10. | Front door - left | Delle | Smart repair |

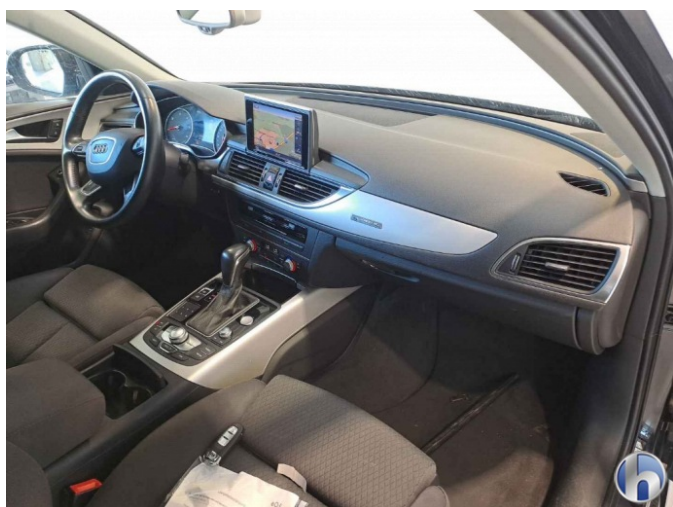
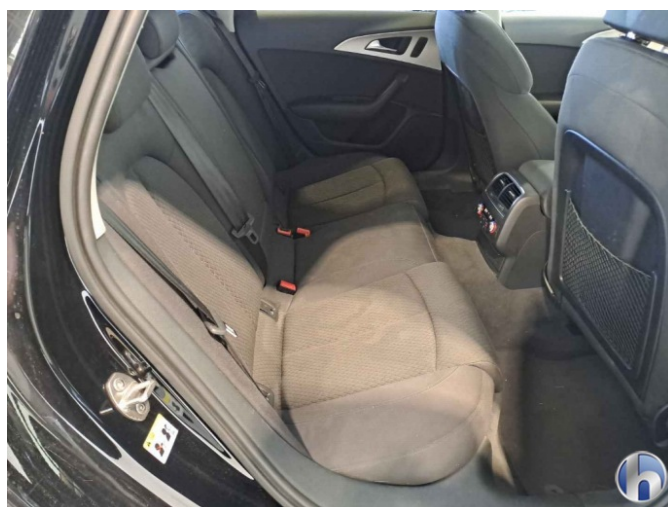
inside

| | <b>component</b> | <b>Damage</b> | <b>Rep kind</b> |
|---|---|---|---|
| 21. | flooring | Burn hole | Smart repair |

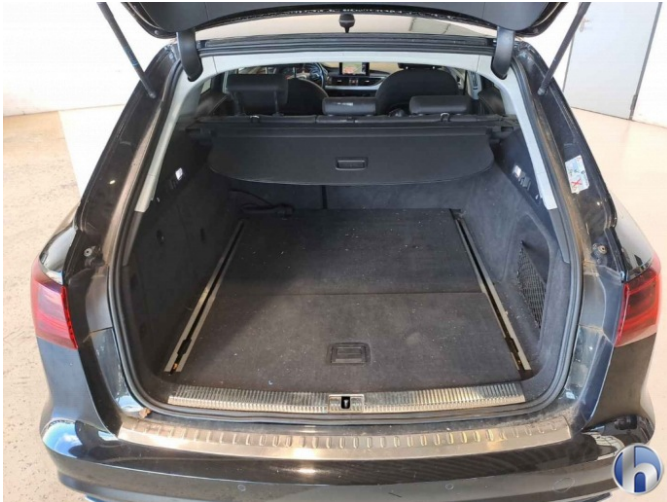
trunk

| | <b>component</b> | <b>Damage</b> | <b>Rep kind</b> |
|---|---|---|---|
| 20. | Trunk Flooring | Damaged | Replace |

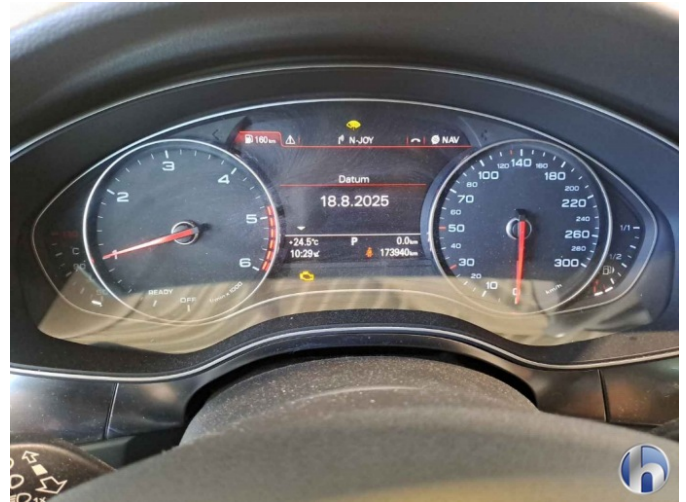
instrument cluster

| Performed testing technology | |
|---|---|
| <b>engine running:</b> | A field test of the engine had to acoustic or visual defects for visiting time .<br>**Engine warning light. |

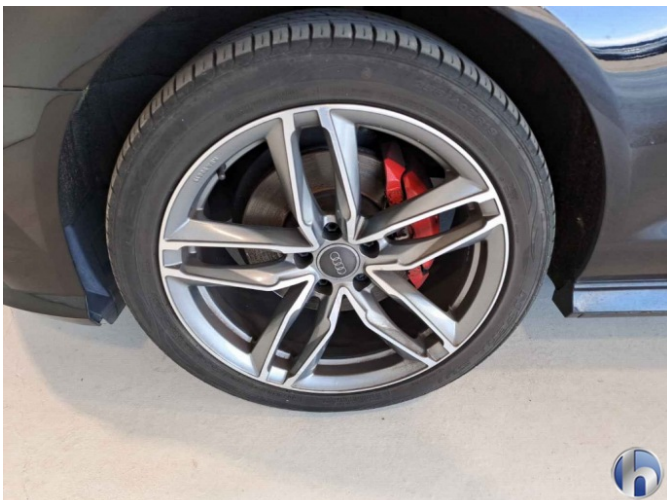
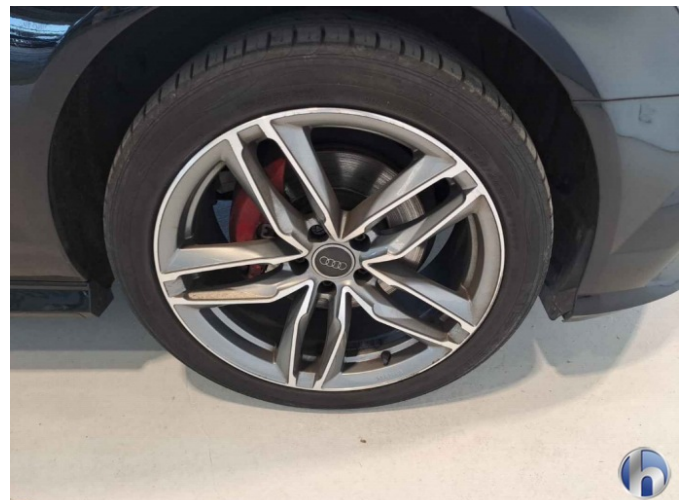
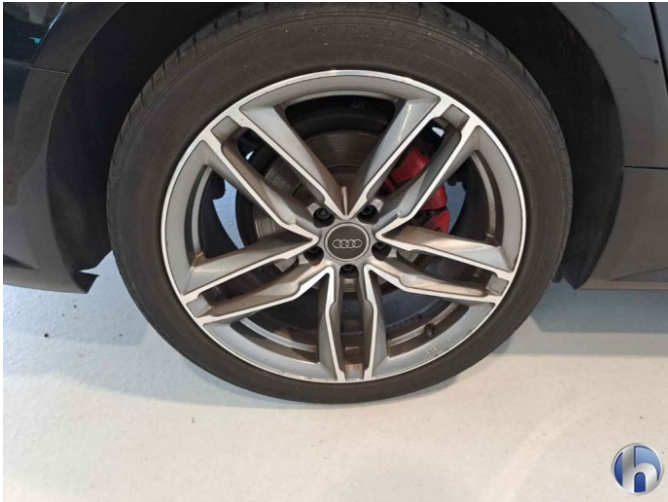
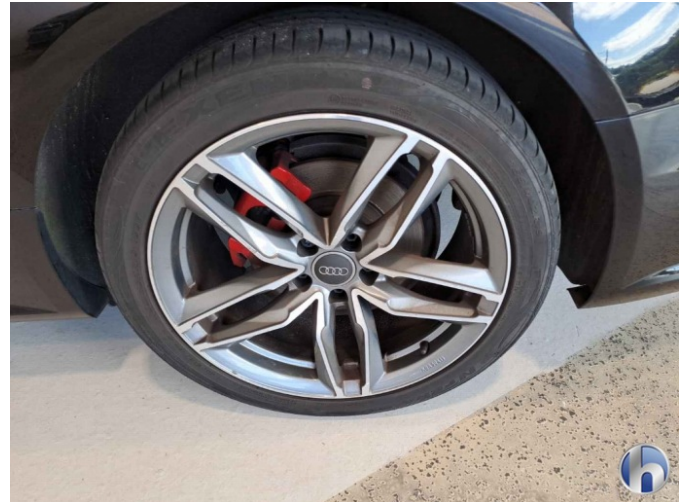
rims

| | <b>component</b> | <b>Damage</b> | <b>Rep kind</b> |
|---|---|---|---|
| 8. | Rim rear - left | Scratch(es) | Replace |
| 13. | Rim front - right | Scratch(es) | Replace |

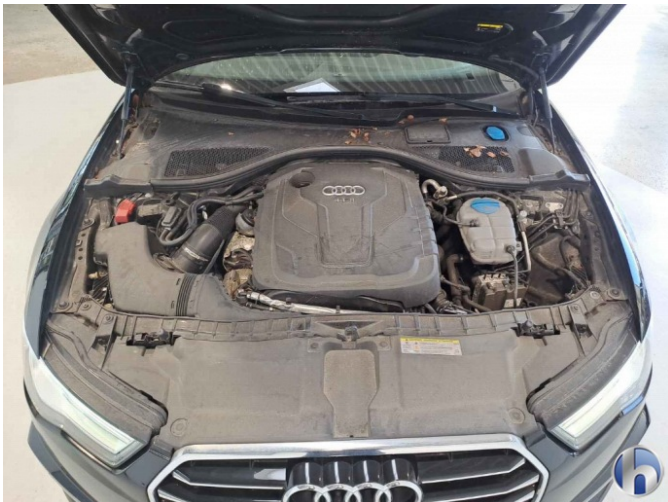
engine compartment

| Performed testing technology | |
|---|---|
| <b>oil loss:</b> | The vehicle could be checked only limited to oil leaks . |
