## status report

#### Audi A6 Allroad quattro 3.0 TDI

| Vehicle identification number | <b>WAUZZZ4G6JN034826</b> | mileage read: | <b>161570 km</b> |

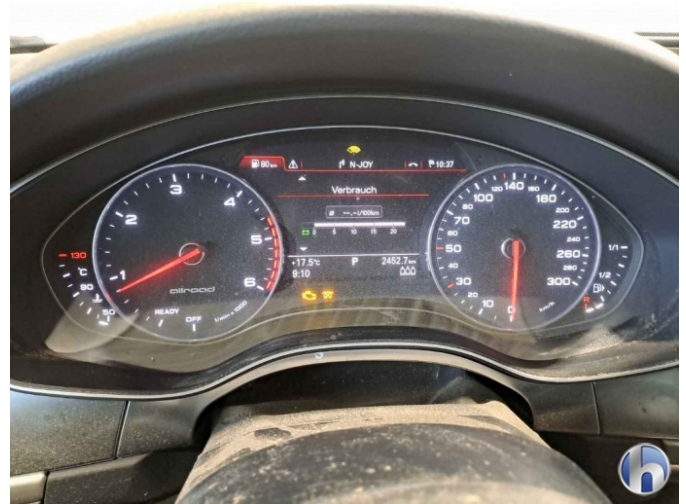
instrument cluster

| Performed testing technology | |
|---|---|
| <b>engine running:</b> | A field test of the engine had to acoustic or visual defects for visiting time .<br>**Engine warning light. It rattles were found. |

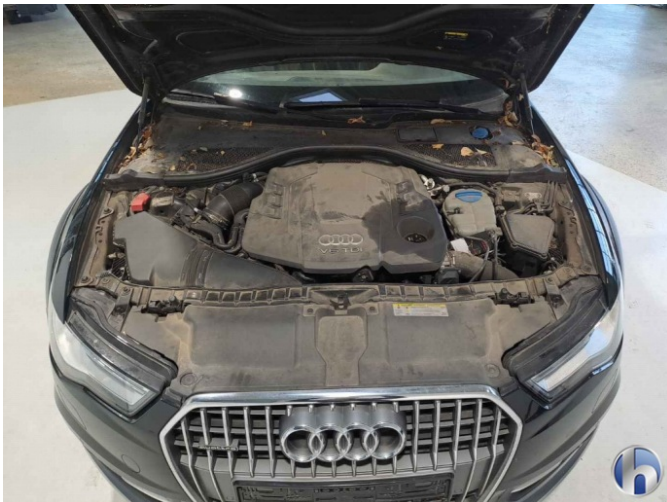
engine compartment

| Performed testing technology | |
|---|---|
| <b>reference:</b> | *Fahrzeug hat Alter und Laufleistungs bedingte Gebrauchsspuren innen und außen MIL<br>Fehlermeldung Fehlerdiagnose durchführen lassen Motor unnormale Geräusche Schaden und<br>Kosten Erweiterung möglich |
