## status report

#### Audi Q7 4.2 TDI quattro

| Vehicle identification number | <b>WAUZZZ4L8AD021742</b> | mileage read: | <b>123734 km</b> |

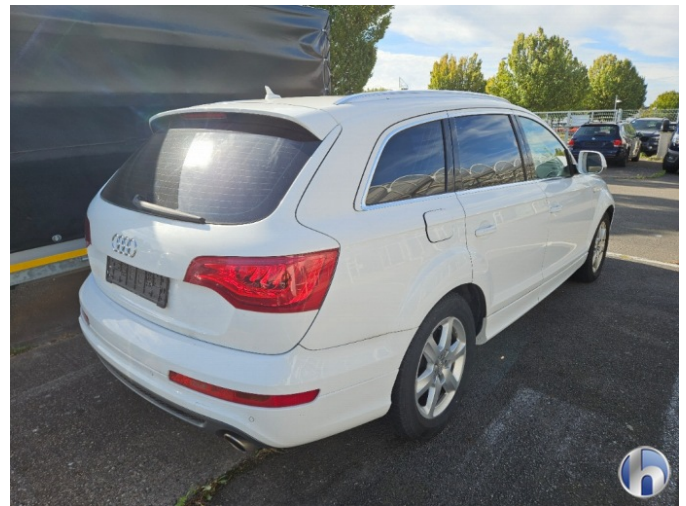
rear Right

| component | Damage | Rep kind |
|---|---|---|
| 10. Sidewall - Rear - right | Corroded | Paint |
| 11. Door Rear - right | Wear and tear | acceptable |

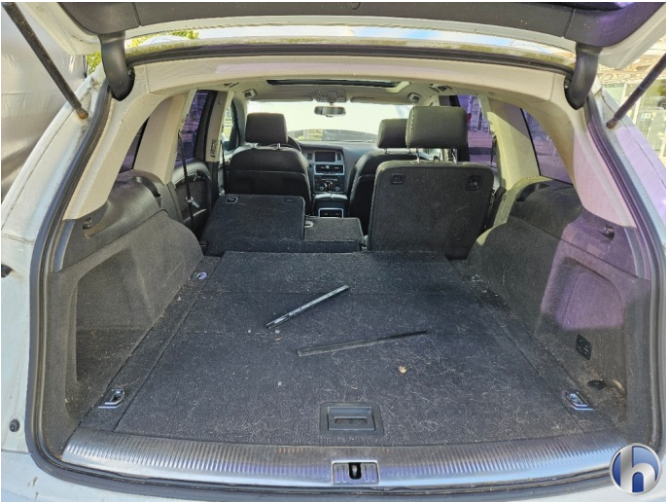
trunk

| component | Damage | Rep kind |
|---|---|---|
| 7. Cargo cover | Missing | Replace |

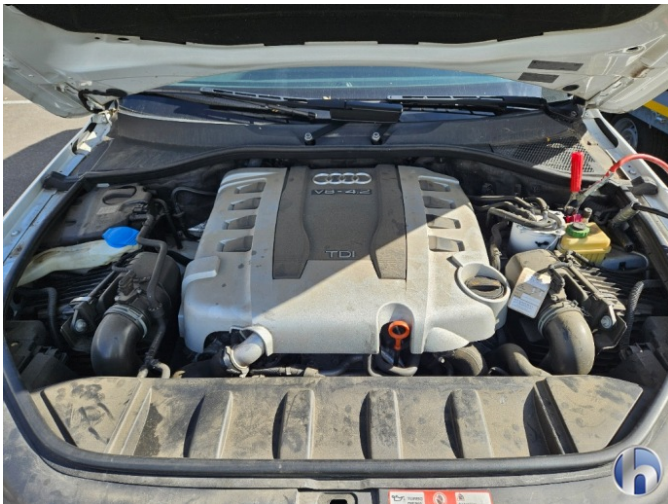
engine compartment

| Performed testing technology | |
|---|---|
| <b>reference:</b> | *Motor startet nicht, größere Schäden möglich |

| component | Damage | Rep kind |
|---|---|---|
| 3. battery | Damaged | Replace |
