## status report

#### Audi A5 Sportback 2.0 TDI quattro

| Vehicle identification number | <b>WAUZZZ8T7GA028458</b> | mileage read: | <b>110850 km</b> |

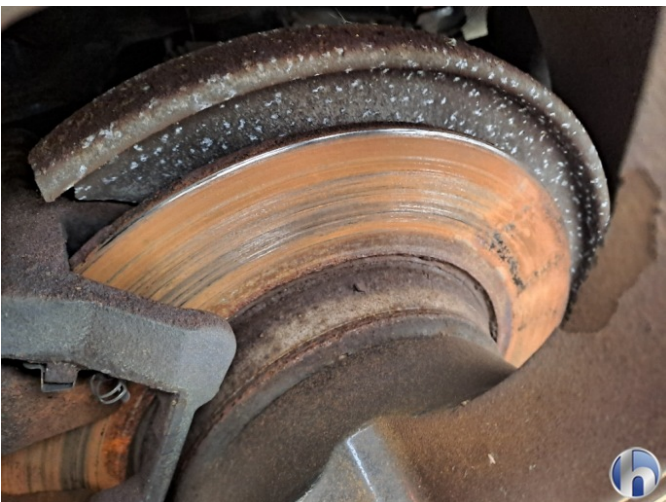
| component | Damage | Rep kind |
|---|---|---|
| 14. Bremse Komplett Hinten fehlt der Belag | Due | Replace |
