## status report

| <b>customer:</b> | <b>Bank 11, Neuss</b> |

| vehicle data | | | |
|---|---|---|---|
| <b>BMW Baureihe X1 sDrive 18 i</b> | | | |
| Vehicle identification number | <b>WBA31AA0903M88505</b> | mileage read: | <b>89953 km</b> |

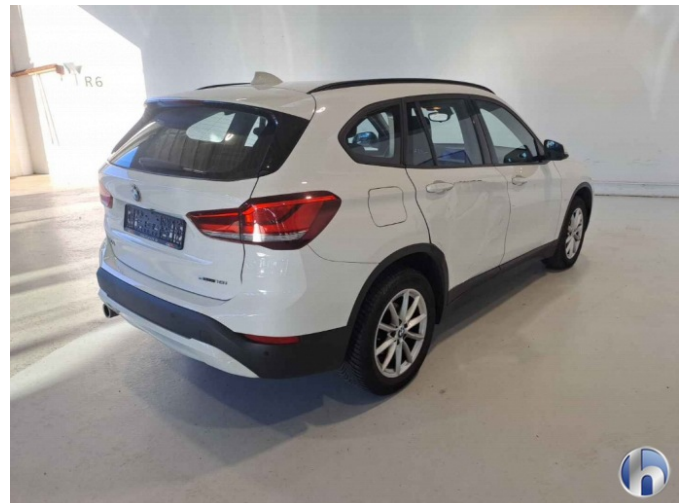
rear Right

| <b>reference:</b> | Tür und Seitenteil HR. Fahrzeug mit bestehenden Unfallschaden, zur Schadensermittlung wurden keine Demontagearbeiten durchgeführt, verborgen gebliebene Schäden können nicht ausgeschlossen werden. Unfallschaden Kosten wurden überschlägig Kalkuliert, Kostenerweiterung möglich. |

| component | Damage | Rep kind |
|---|---|---|
| 12. Door Rear - right | Accident damage | Replace |
| 14. Sidewall - Rear - right | Accident damage | Refurbish and paint |

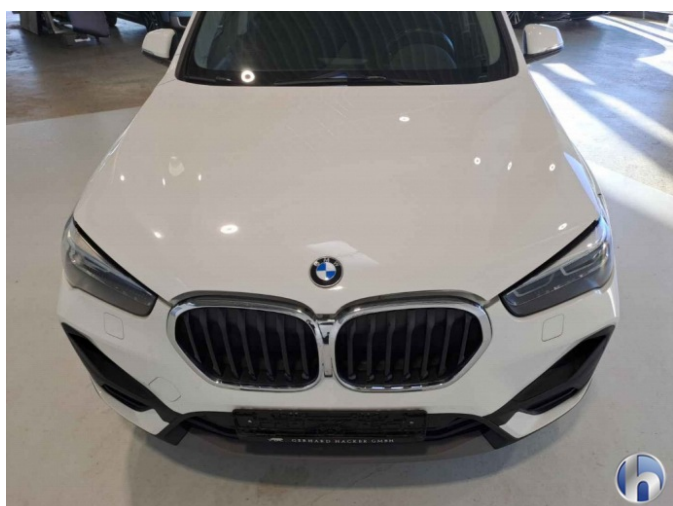
engine compartment

| Performed testing technology | |
|---|---|
| <b>engine running:</b> | A field test of the engine had to acoustic or visual defects for visiting time .<br>**It rattles were found. |
