## status report

#### BMW Baureihe 3 Gran Turismo 330 d xDrive

| Vehicle identification number | <b>WBA3Z51000D398573</b> | mileage read: | <b>206985 km</b> |

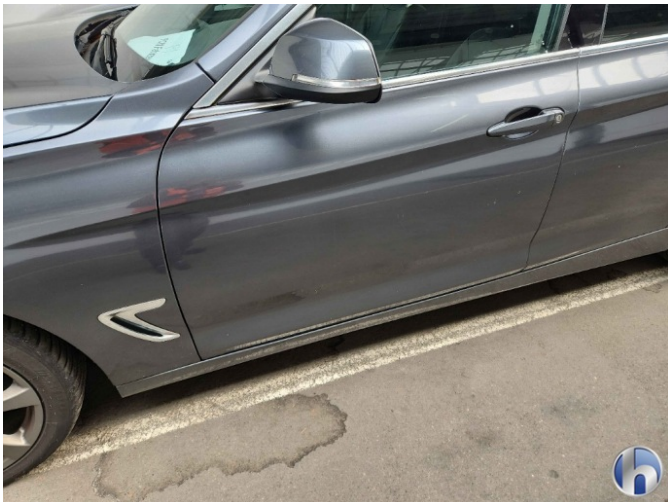
2. Front door - left

| | component | Damage | Rep kind |
|---|---|---|---|
| 2. | Front door - left | Execution defect | Refurbish and paint |

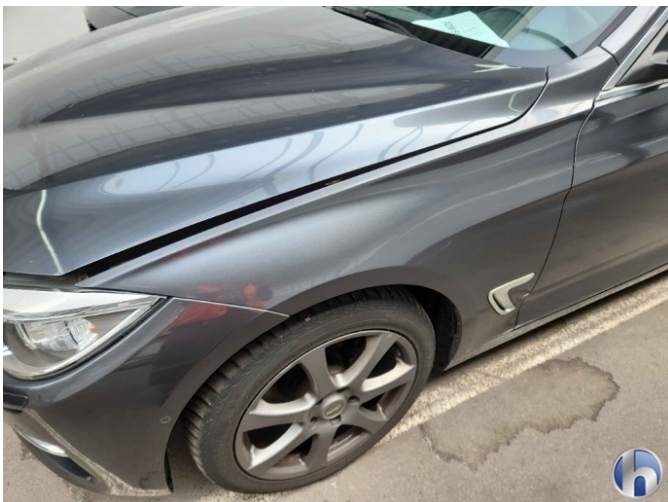
3. Front fender - left

| | component | Damage | Rep kind |
|---|---|---|---|
| 3. | Front fender - left | Execution defect | Refurbish and paint |

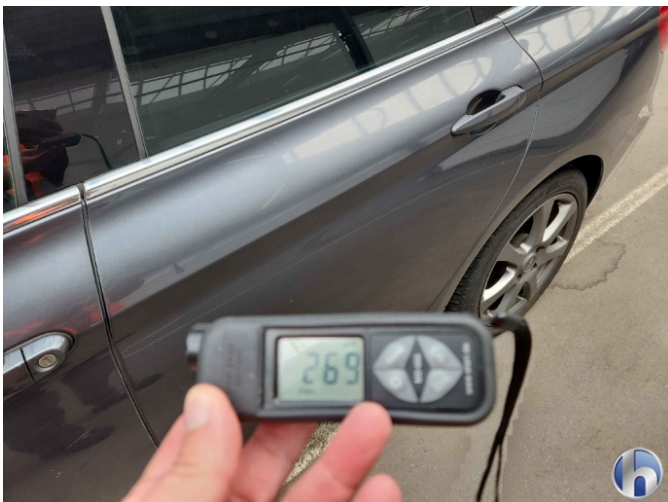
4. Rear door - left

| | component | Damage | Rep kind |
|---|---|---|---|
| 4. | Rear door - left | Execution defect | Paint |

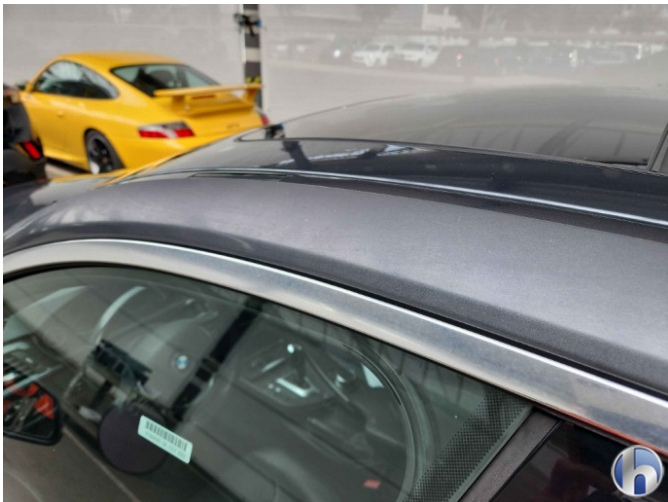
5. Sidewall - Rear - Left

| | component | Damage | Rep kind |
|---|---|---|---|
| 5. | Sidewall - Rear - Left | Execution defect | Refurbish and paint |

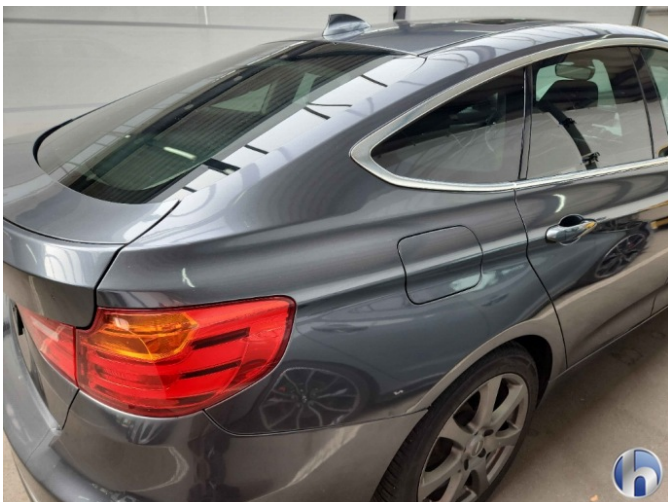
6. Sidewall - Rear - right

| | component | Damage | Rep kind |
|---|---|---|---|
| 6. | Sidewall - Rear - right | Execution defect | Refurbish and paint |

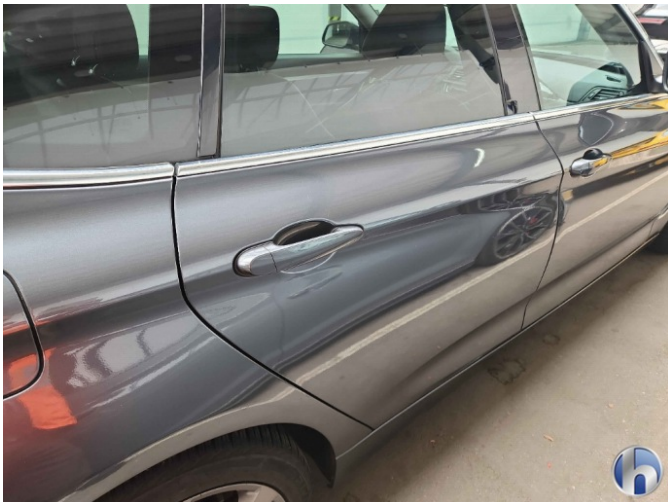
7. Door Rear - right

| | component | Damage | Rep kind |
|---|---|---|---|
| 7. | Door Rear - right | Execution defect | Refurbish and paint |

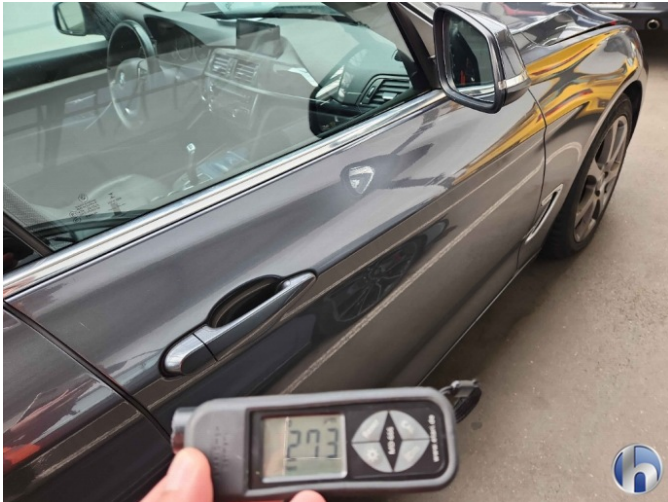
8. Front door - right

| | component | Damage | Rep kind |
|---|---|---|---|
| 8. | Front door - right | Execution defect | Refurbish and paint |

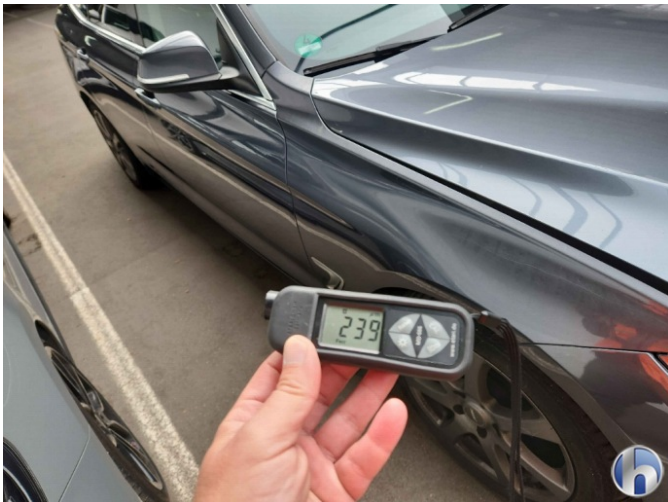
9. Front fender - right

| | component | Damage | Rep kind |
|---|---|---|---|
| 9. | Front fender - right | Execution defect | Refurbish and paint |

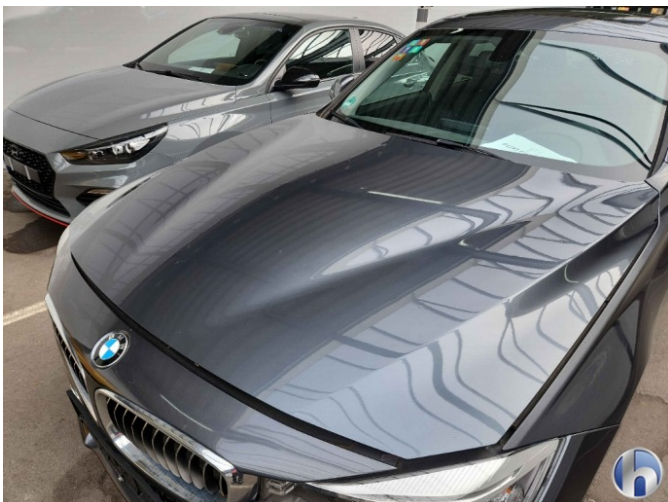
10. hood

| | component | Damage | Rep kind |
|---|---|---|---|
| 10. | hood | Hail damage | Refurbish and paint |

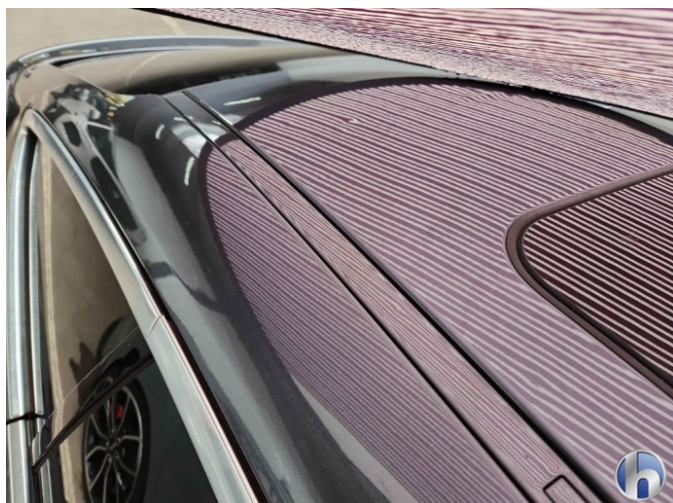
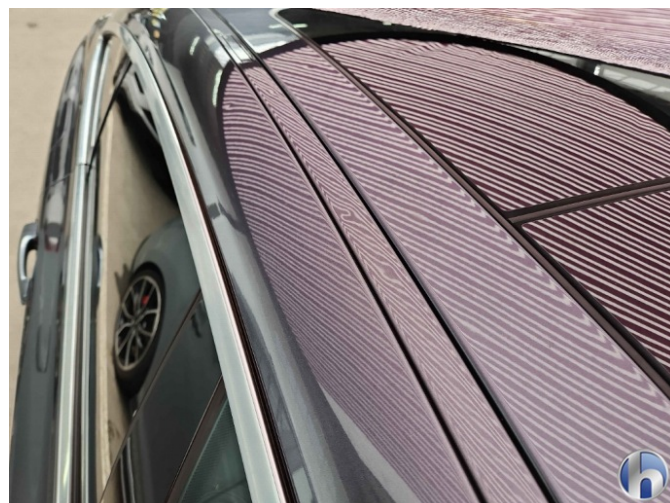
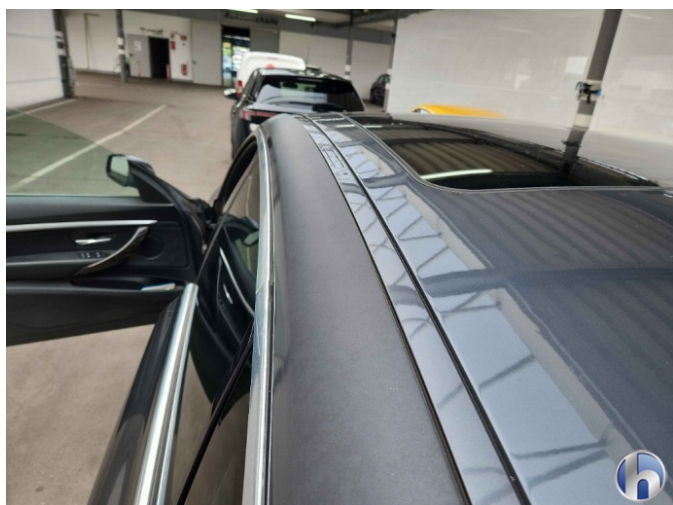
| | component | Damage | Rep kind |
|---|---|---|---|
| 12. | | Damaged | Replace |

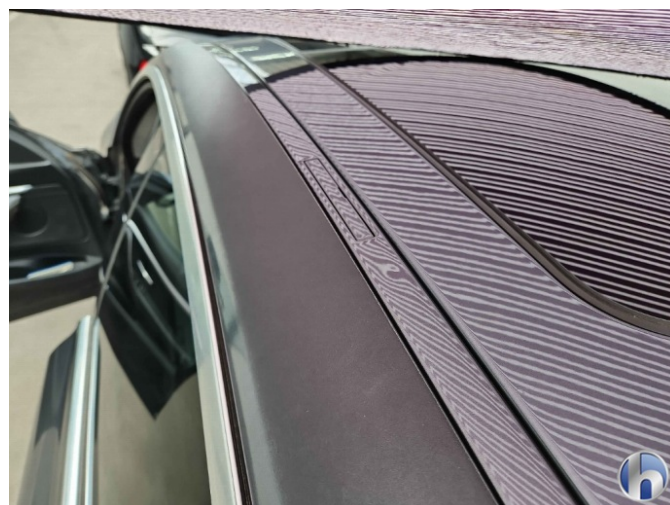
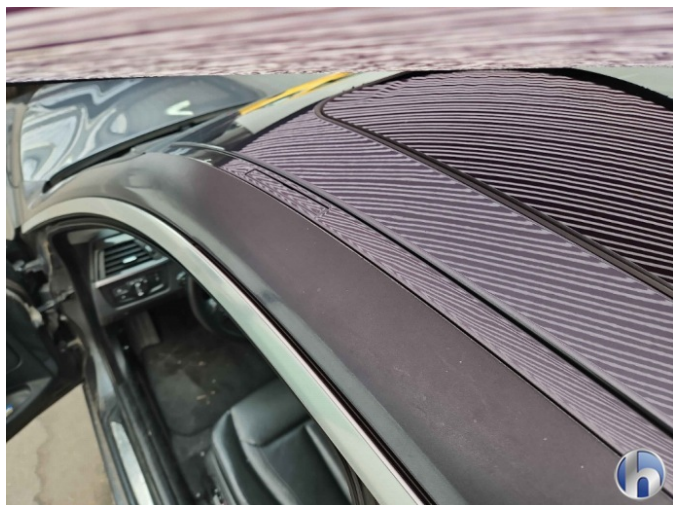
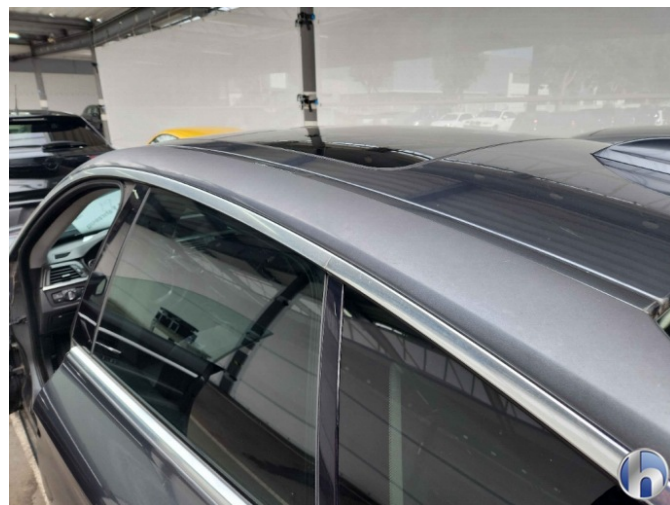
| | component | Damage | Rep kind |
|---|---|---|---|
| 13. | | Damaged | Replace |

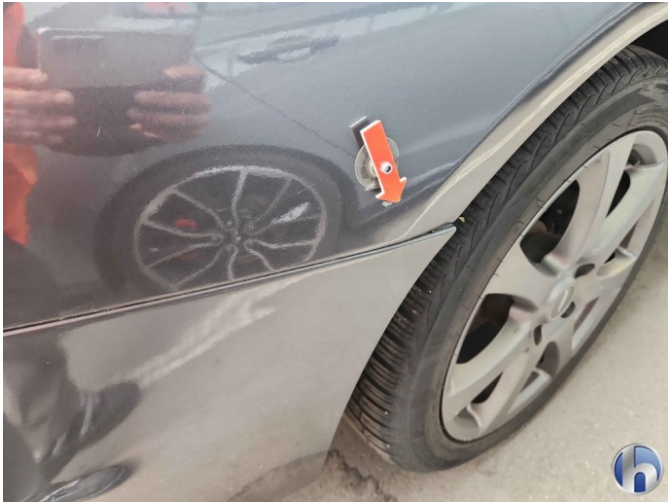
18. Rear bumper

| | component | Damage | Rep kind |
|---|---|---|---|
| 18. | Rear bumper | Damaged | Replace |

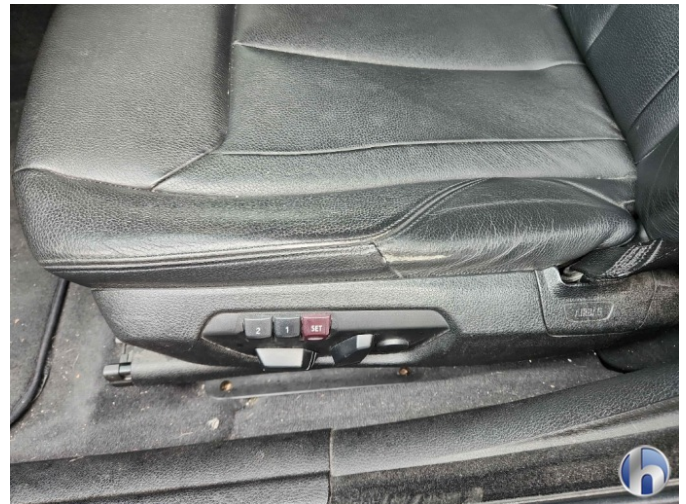
| | component | Damage | Rep kind |
|---|---|---|---|
| 22. | | Damaged | Replace |

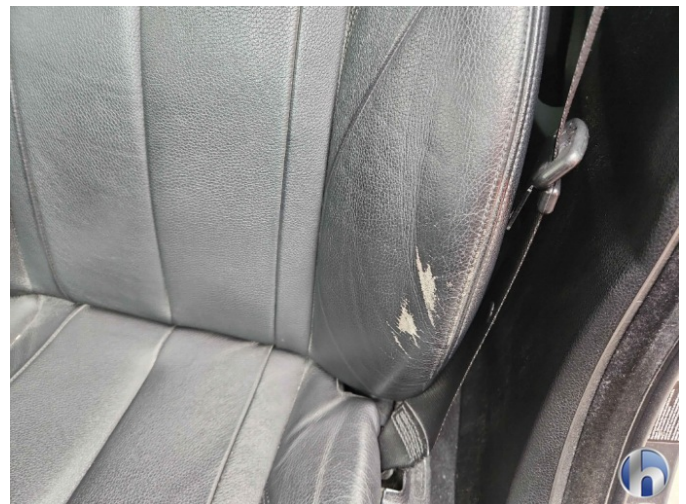
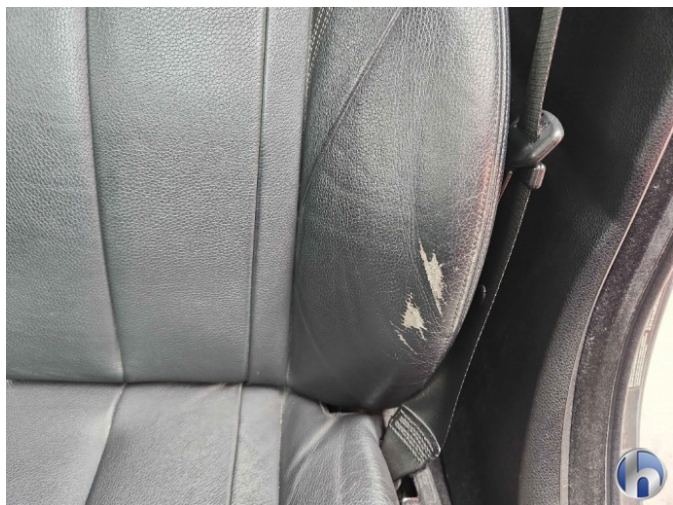
| | component | Damage | Rep kind |
|---|---|---|---|
| 23. | | Damaged | Replace |
