# BMW 3er 320d Touring Aut.

VIN NO WBA6L51000FJ23353  
Registration Number 000FJ23353

## Inspection Report Summary

| Customer | BCA Online | Report Number | P20250721143151 |

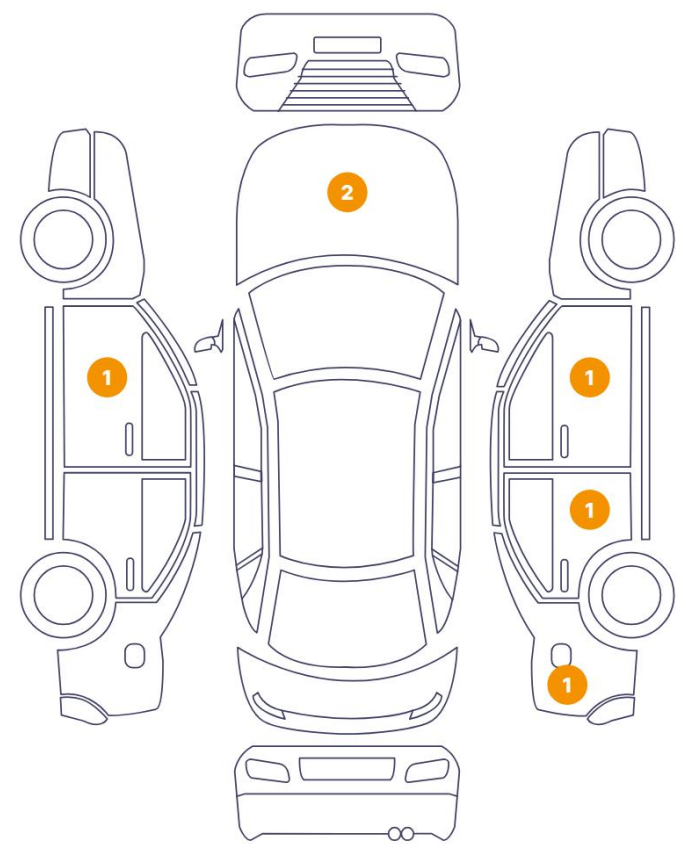
6 Schäden

| Component | | Damage | Comments |
|---|---|---|---|
| 1 | Pillar / Back Right | Paint / Scratch / Scuff | |
| 4 | Luggage Space Cover / Back | Interior / Missing | |
| 5 | Door / Front Left | Paint / Poor Previous Repair | |
