## status report

#### BMW Baureihe 3 Cabrio 320d

| Vehicle identification number | <b>WBADY31010E828357</b> | mileage read: | <b>262248 km</b> |

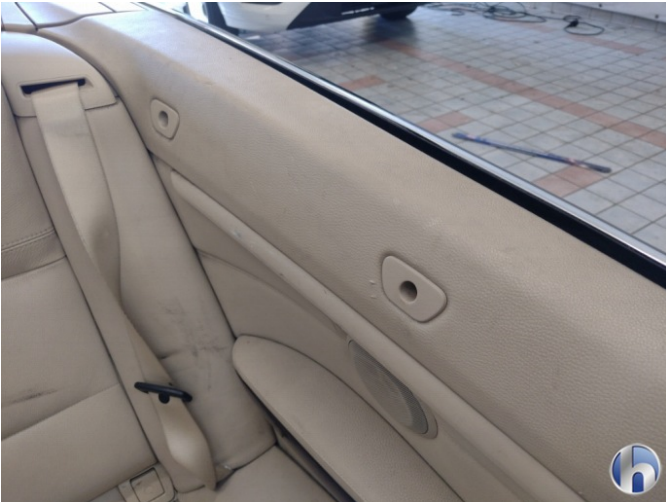
| component | Damage | Rep kind |
|---|---|---|
| 9. Innenverkleidung Hinten Links und Rechts | Damaged | Smart repair |

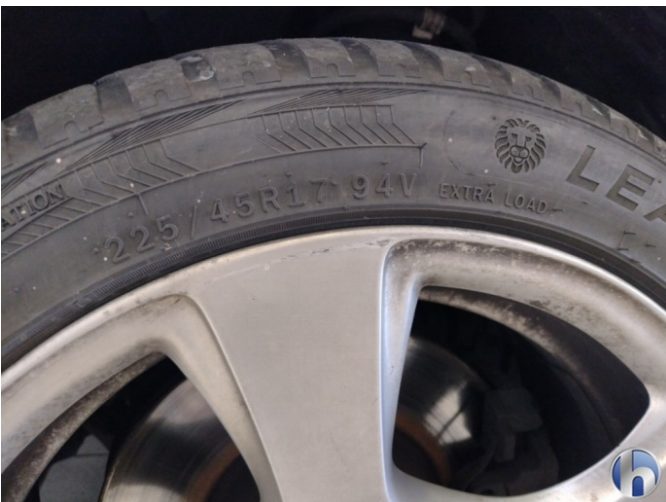
| component | Damage | Rep kind |
|---|---|---|
| 12. Rim front - left | Scratch(es) | Smart repair |
