## status report

#### BMW Baureihe 5 Lim. 520 i Sport Line

| Vehicle identification number | <b>WBAJK51020BX22422</b> | mileage read: | <b>111191 km</b> |

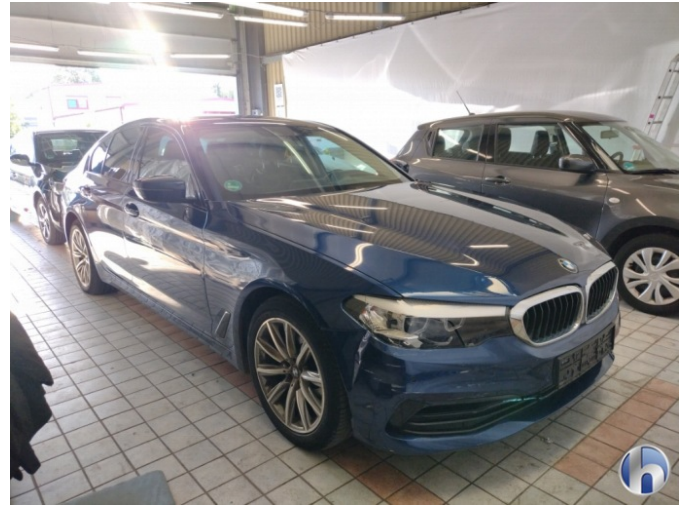
front Right

| Performed testing technology | |
|---|---|
| <b>lighting system:</b> | For sightseeing timing defects in the lighting system were noted .<br>*Unfallschaden Vorne Rechts Schadensenerweiterung möglich. |

| component | Damage | Rep kind |
|---|---|---|
| 14. Unfallschaden Vorne Rechts<br>Schadenserweiterung möglich | Accident damage | Replace |

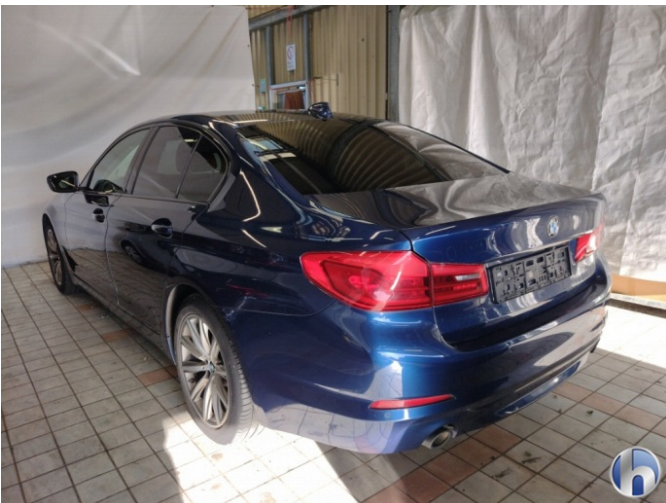
rear Left

| component | Damage | Rep kind |
|---|---|---|
| 19. Rear door - left | Damaged | Paint |

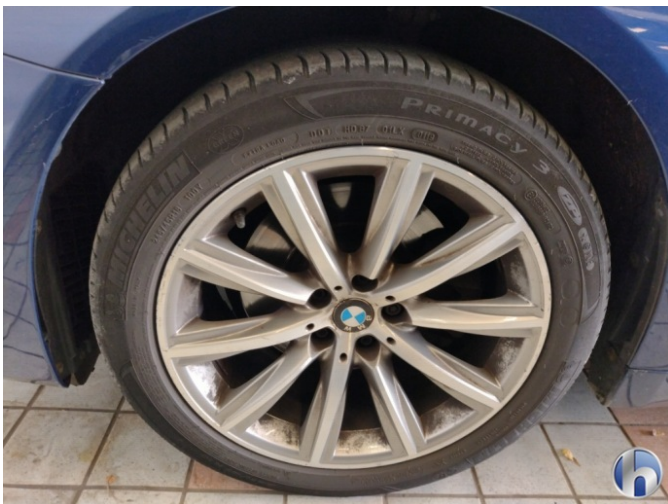
rims

| component | Damage | Rep kind |
|---|---|---|
| 11. Rim rear - left | Damaged | Replace |
| 12. Rim rear - right | Damaged | Replace |
| 13. Rim front - right | Damaged | Replace |
