## status report

#### BMW Baureihe X6 xDrive 40 d

| Vehicle identification number | <b>WBAKV410200P70830</b> | mileage read: | <b>182717 km</b> |

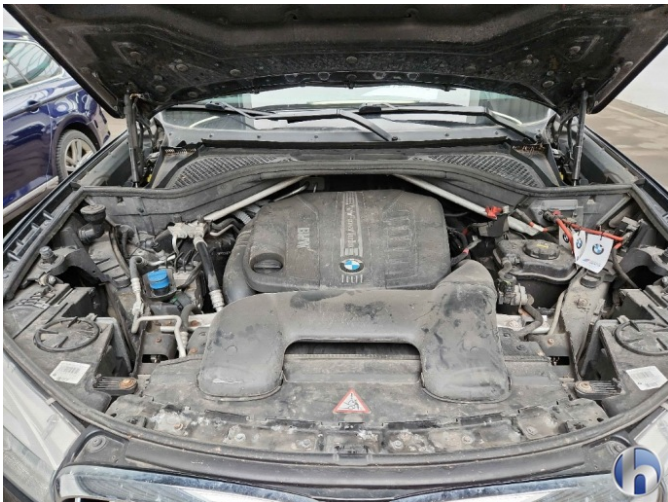
engine compartment

| Performed testing technology | |
|---|---|
| <b>oil loss:</b> | The vehicle could be checked only limited to oil leaks . |
