BMW 3er 320d DPF Touring Aut.

VIN NO WBAVU51080A317991 Registration Number 080A317991

Inspection Report Summary

Customer	BCA Online	Report Number	P20250508132400
Inspection Date / Place	2025-05-08 / BCA Neuss	Cosmetic Grade	4

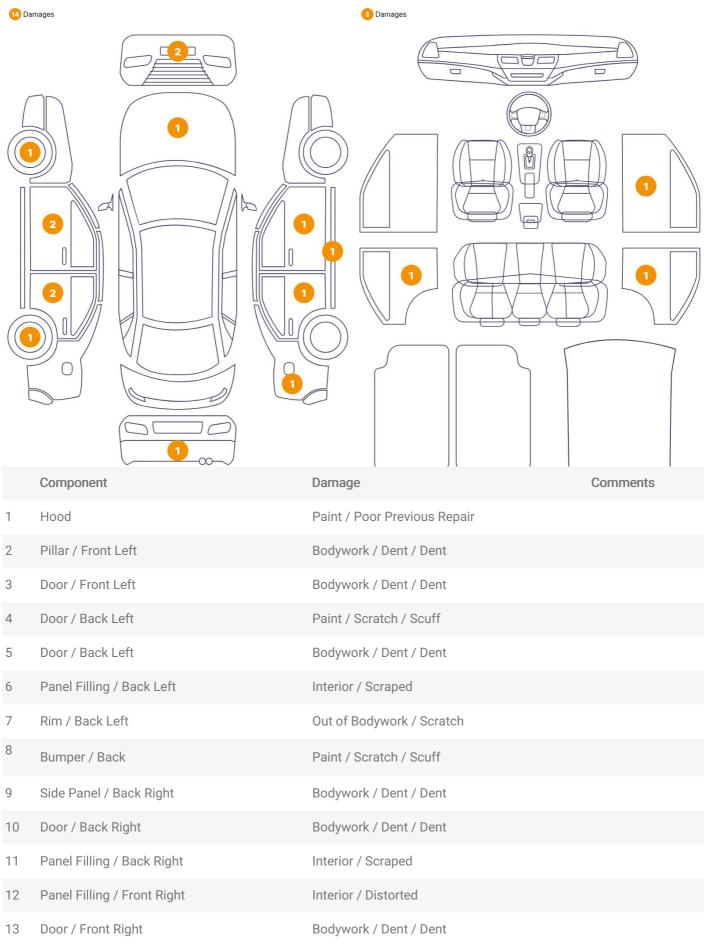
14	Rocker Panel / Center Right	Paint / Scratch / Scuff
15	Bumper / Front	Paint / Scratch / Scuff
16	Bumper / Front	Paint / Scratch / Scuff
17	Rim / Front Left	Out of Bodywork / Scratch

1. Hood Paint / Poor Previous Repair -
