## status report

#### Mercedes-Benz C -Klasse Lim. C 220 CDI

| Vehicle identification number | <b>WDB2030081A861170</b> | mileage read: | <b>161428 km</b> |

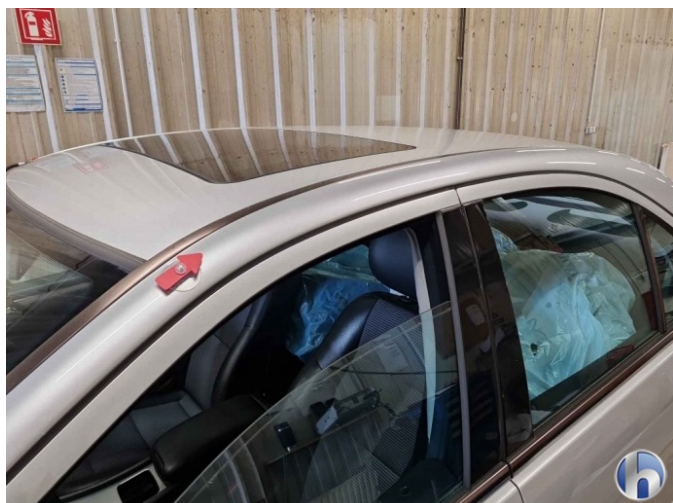
| component | Damage | Rep kind |
|---|---|---|
| 33. A-pillar Front - Left | Damaged | Refurbish and paint |
