## status report

**customer:** BCA Autoauktionen GmbH

#### Mercedes-Benz Sprinter II Kasten 310/311/313/314/316 CDI

| Vehicle identification number | <b>WDB9066331P334142</b> | mileage read: | <b>246686 km</b> |

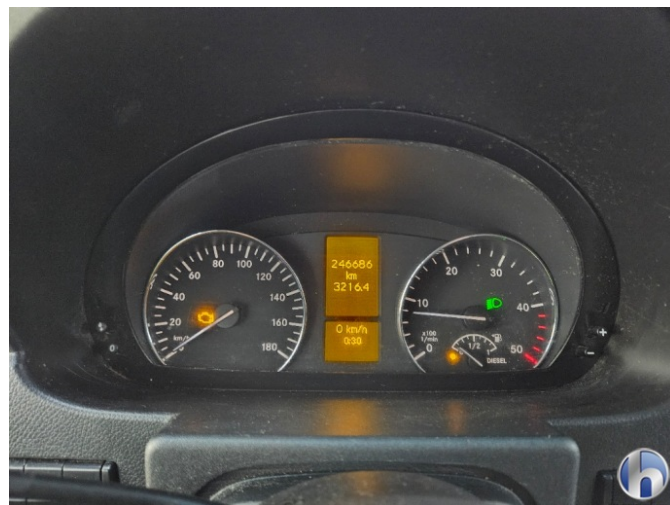
instrument cluster

| Performed testing technology | |
|---|---|
| <b>engine running:</b> | A field test of the engine had to acoustic or visual defects for visiting time .<br>**Engine warning light. |

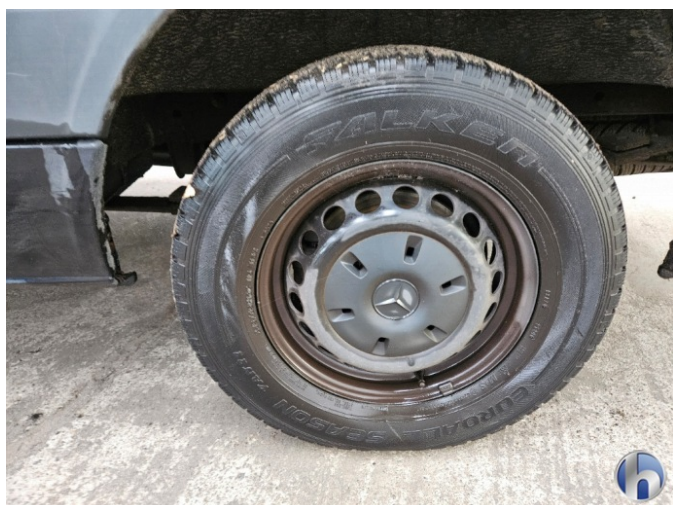
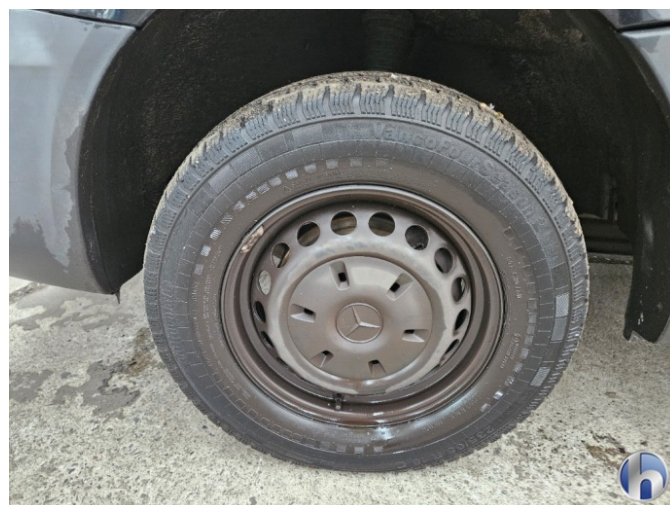
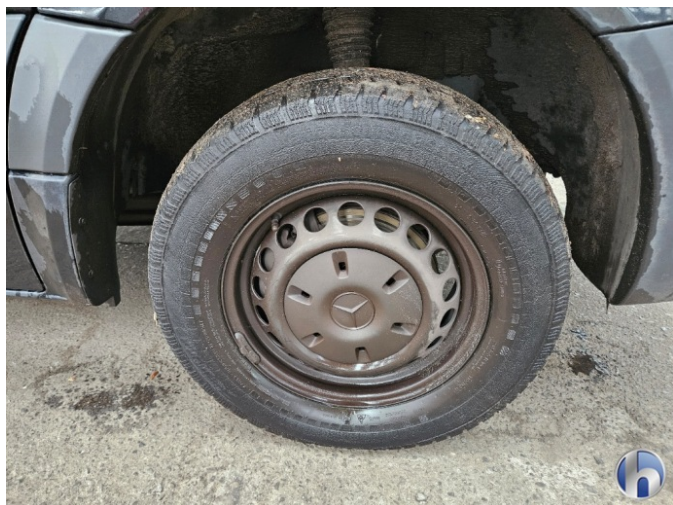
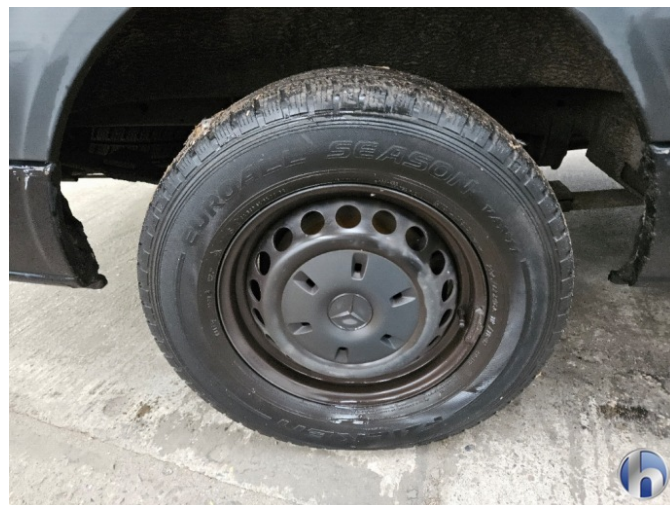
rims

| General examination | |
|---|---|
| <b>Note Road Safe:</b> | Reifen Verschleißgrenze erreicht |

| component | Damage | Rep kind |
|---|---|---|
| 10. Reifen 4x | Not safe for road traffic | Replace |

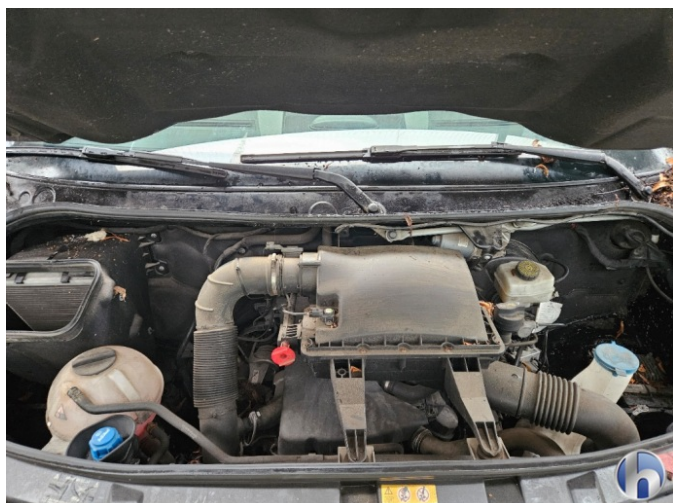
engine compartment

| Performed testing technology | |
|---|---|
| <b>oil loss:</b> | The vehicle could be checked only limited to oil leaks . |
