## MERCEDES-BENZ M-Klasse ML 350 4MATIC (BlueEFFICIENCY) 7G-**TRONIC**

VIN NO WDC1660571A007638 Registration Number 571A007638

### **Inspection Report Summary**

| Customer | BCA Online | Report Number | P20250725094810 |

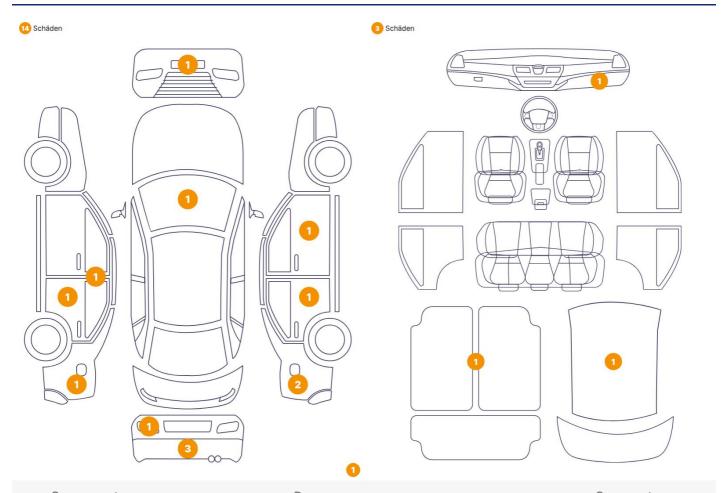
## Cosmetic Damage

| | Component | Damage | Comments |
| 1 | Roof Upholstery | Interior / Dirty | |
| 2 | Floor Carpet | Interior / Dirty | |
| 3 | Center Console | Interior / Scraped | |
| 4 | B Pillar / Center Left | Paint / Scratch / Scuff | |
| 5 | Bumper / Back | Bodywork / Breakage / Crack | |
| 6 | Bumper / Back | Paint / Scratch / Scuff | |
| 7 | Bumper / Back | Paint / Scratch / Scuff | |
| 8 | Back Light / Left | Bodywork / Breakage | |
| 9 | Side Panel / Back Left | Bodywork / Dent / Dent | |
| 10 | Door / Back Left | Bodywork / Dent / Dent | |
| 11 | Bumper / Front | Paint / Scratch / Scuff | |
| 12 | Windshield / Front | Glass Break / Impact | |
| 13 | Door / Back Right | Bodywork / Dent / Dent | |

| 14 | Door / Front Right | Bodywork / Dent / Dent |
| 15 | Side Panel / Back Right | Bodywork / Dent / Dent |
| 16 | Side Panel / Back Right | Bodywork / Dent / Dent |
| 17 | Other | Anomalyon Element |
