## status report

#### Mercedes-Benz A -Klasse A 220 CDI / d BlueEfficiency

| Vehicle identification number | <b>WDD1760031J461457</b> | mileage read: | <b>101062 km</b> |

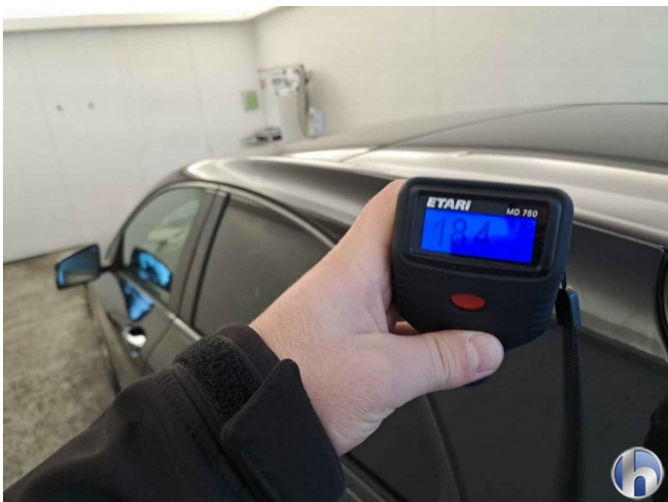
5. Roof frame - left

| component | Damage | Rep kind |
|---|---|---|
| 22. Roof frame - left | Damaged | Refurbish and paint |

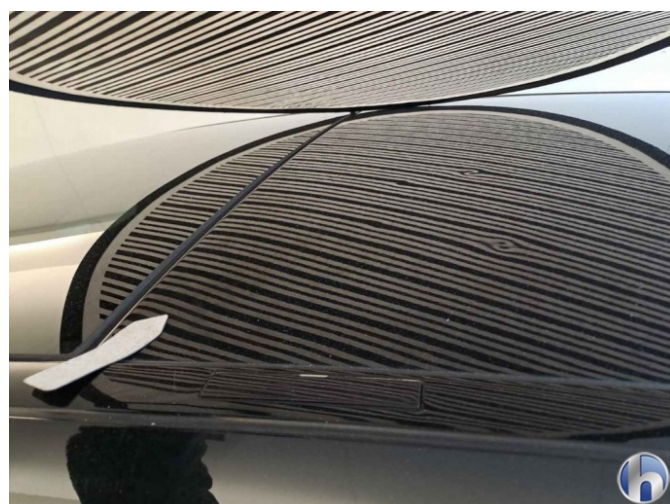
| component | Damage | Rep kind |
|---|---|---|
| 24. Dach mit 15 Dellen à 20mm-30mm | Hail damage | Refurbish and paint |

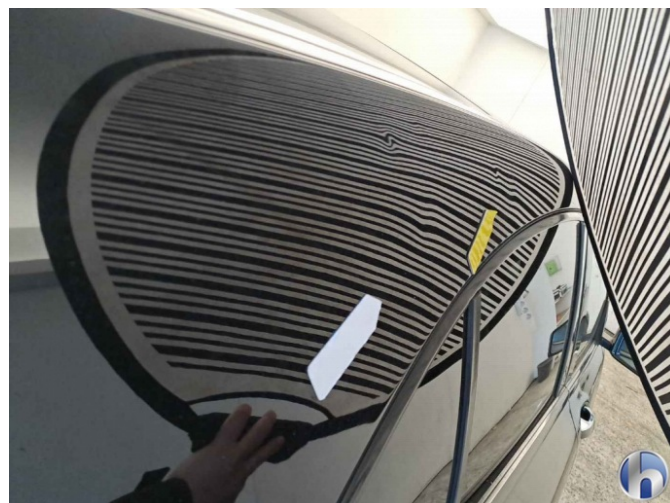
42. Roof frame - right

| 42. | Roof frame - right | Hail damage | Refurbish and paint |
