## status report

**customer:** BCA Autoauktionen GmbH

#### Mercedes-Benz C -Klasse Lim. C 180 CGI BlueEfficiency (204.031)

| Vehicle identification number | <b>WDD2040311A751394</b> | mileage read: | <b>302429 km</b> |

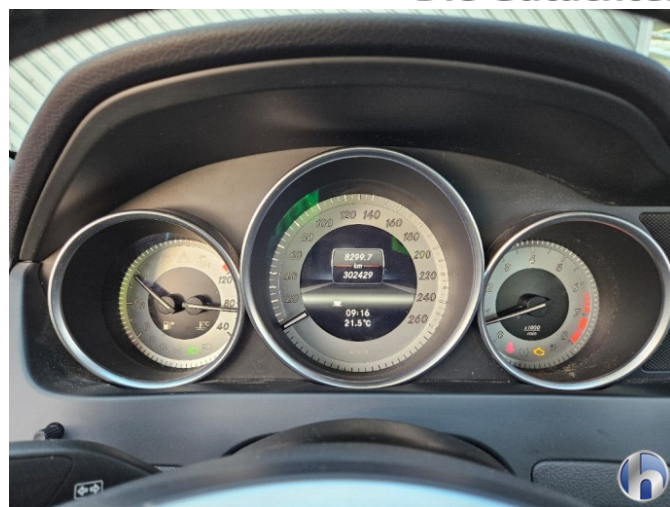
instrument cluster

| Performed testing technology | |
|---|---|
| <b>engine running:</b> | A field test of the engine had to acoustic or visual defects for visiting time .<br>**Engine warning light. |
