MERCEDES-BENZ C-Klasse C 200 T CDI DPF Automatik

Inspection Report Summary

Customer	BCA Online	Report Number	P20250520112152
Inspection Date / Place	2025-05-20 / BCA Heidenheim	Cosmetic Grade	4

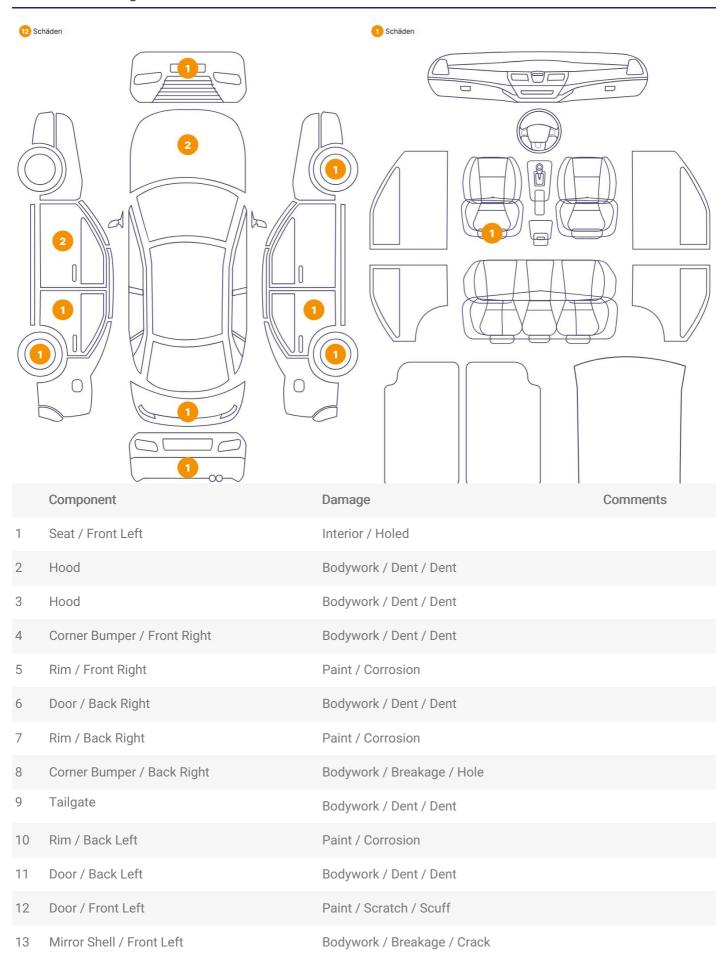
1. Seat / Front Left Interior / Holed -

5. Rim / Front Right Paint / Corrosion -

7. Rim / Back Right Paint / Corrosion -

10. Rim / Back Left Paint / Corrosion -

13. Mirror Shell / Front Left Bodywork / Breakage / Crack -
