## status report

**customer:** Bank 11, Neuss  
**contract number:** 369723170  
**reference:**

#### Mercedes-Benz E -Klasse Lim. E 350 CDI 4Matic

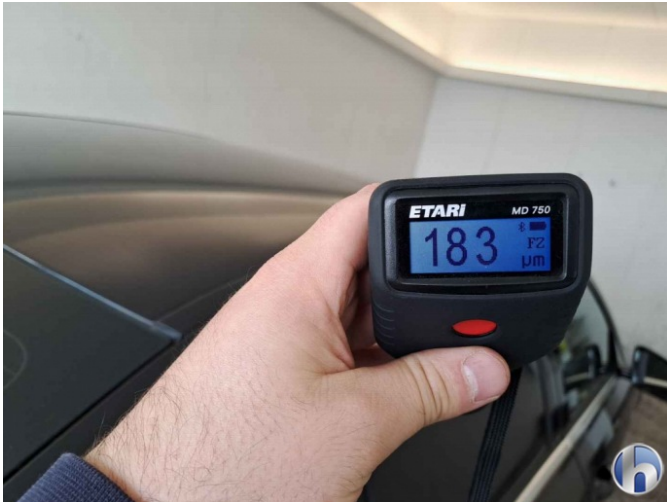
7. Roof frame - right

| 46. | Roof frame - right | Execution defect | Refurbish and paint |

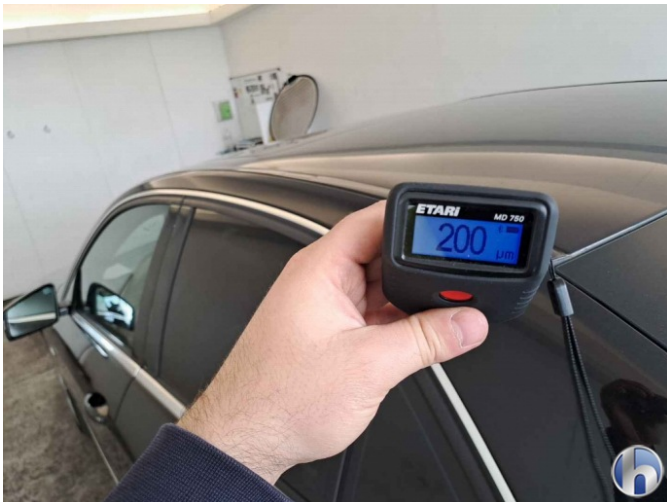
9. Roof frame - left

| component | Damage | Rep kind |
|---|---|---|
| 34. Roof frame - left | Execution defect | Refurbish and paint |

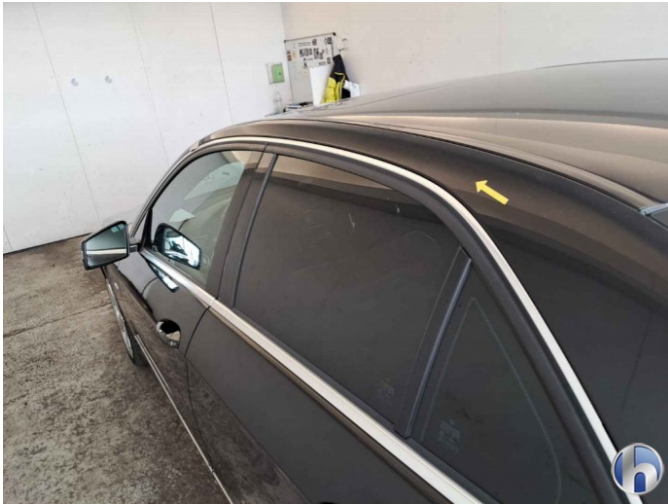
| component | Damage | Rep kind |
|---|---|---|
| 33. | Burn hole | Replace |
