MERCEDES Classe E - S213 SW Diesel
E SW 200 d Sport auto

VIN NO WDD2132131A455312
Registration Number GP415EK

Inspection Report Summary

Customer	BCA Lodi	Report Number	P20251009091403
Inspection Date / Place	2025-10-09 / BCA Lodi	Cosmetic Grade	3

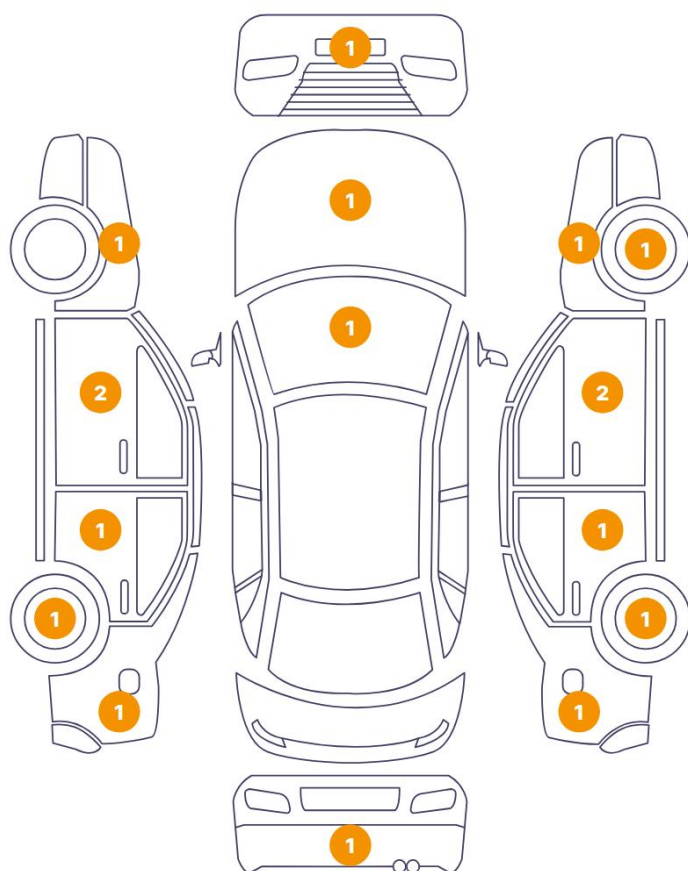
17 Danni

13	Seat / Front Left	Interior / Worn - out
14	Rim / Front Right	Out of Bodywork / Scratch
15	Fender / Back Left	Bodywork / Poor Previous Repair
16	Rim / Back Left	Out of Bodywork / Scratch
17	Rim / Back Right	Out of Bodywork / Scratch
18	Fender / Front Left	Paint / Scratch / Line
