## status report

| <b>customer:</b> | <b>Bank 11, Neuss</b> |
| <b>contract number:</b> | <b>987363530</b> |

| vehicle data | | | |
|---|---|---|---|
| <b>Ford Focus</b> | | | |

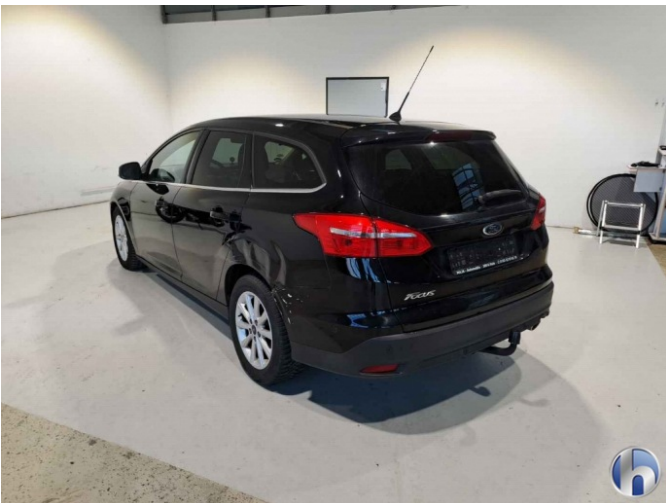
rear Left

| | component | Damage | Rep kind |
|---|---|---|---|
| 5. | Rear bumper | Accident damage | Replace |
| 6. | Sidewall - Rear - Left | Accident damage | Replace |

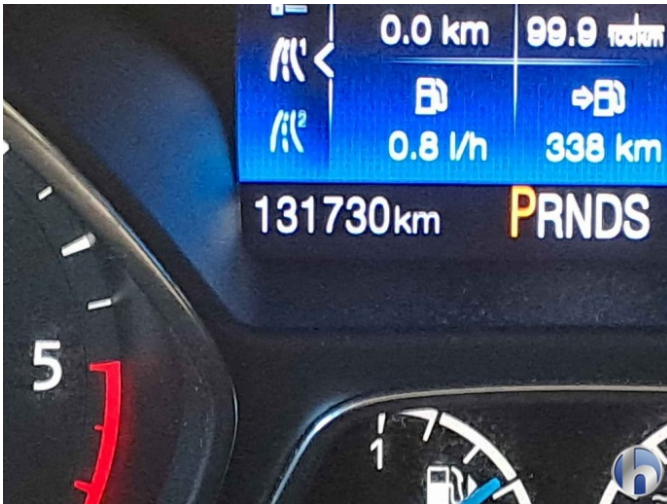
| vehicle data | | | |
|---|---|---|---|
| Vehicle identification number | <b>WF06XXGCCGFU26729</b> | mileage read: | <b>131730 km</b> |

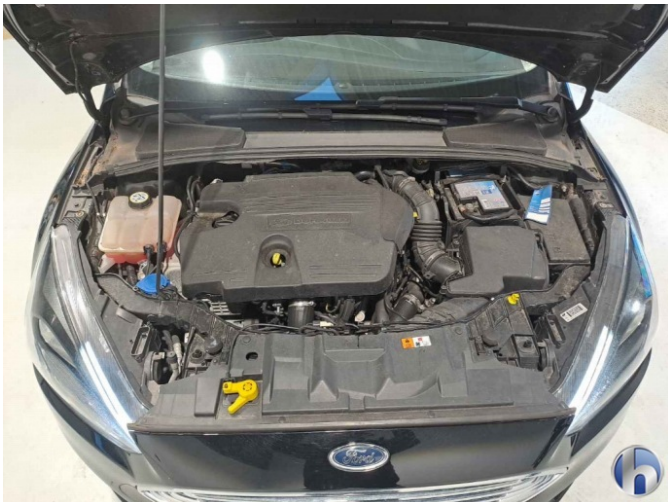
engine compartment

| Performed testing technology | |
|---|---|
| <b>engine running:</b> | Checking the engine running was limited. Here no audible or visual abnormalities were noted . |

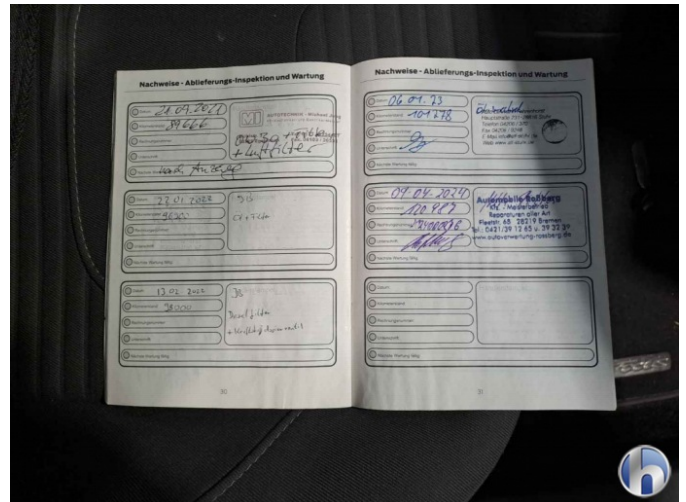
service book

| vehicle data | | | |
|---|---|---|---|
| smoking vehicle: | <b>no</b> | Last service km / on the: | <b>120987 / 09.04.2024</b> |
