Expertise

Protocol number: 41580918  
Order No. / Reference: 25084247  
Inspection date: 16 Sept 2025

| Manufacturer: Ford | Model: Transit Connect 230 L2 S&S Trend |
| VIN: WF07XXWPG7LD27380 | |

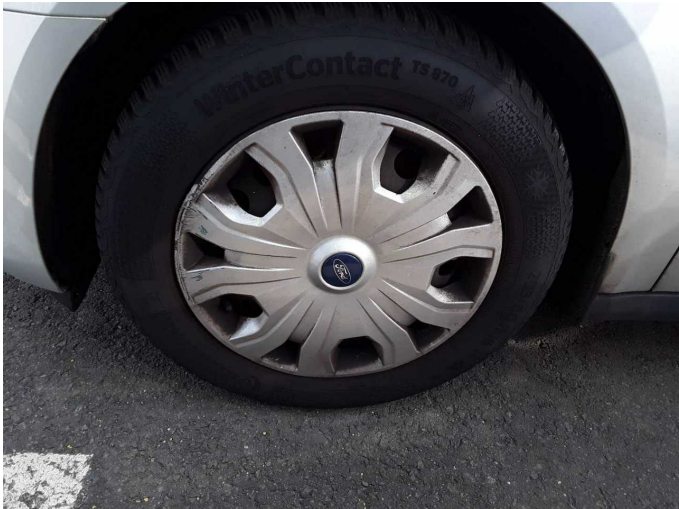
Figure 12: Mounted tyres

- Für den montierten Radsatz wurde kein Nachweis erbracht.

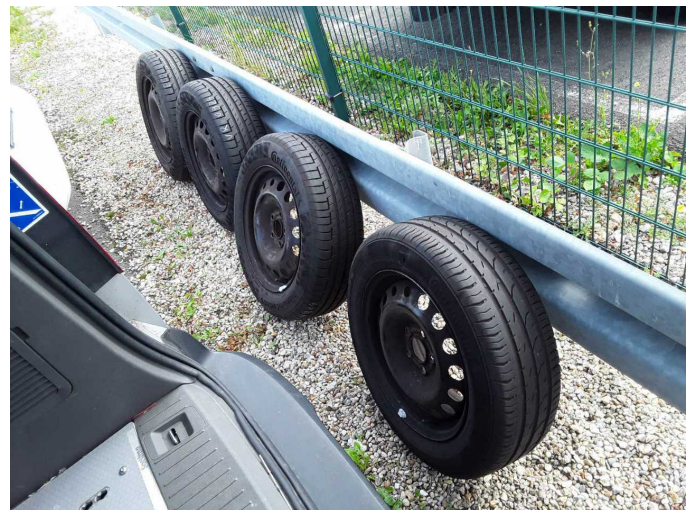
Figure 16: Additional tyres

| No. | Component group | Description |
|---|---|--|
| 2 | 2nd wheel set | 1 tyre - Broken / torn - Replace |

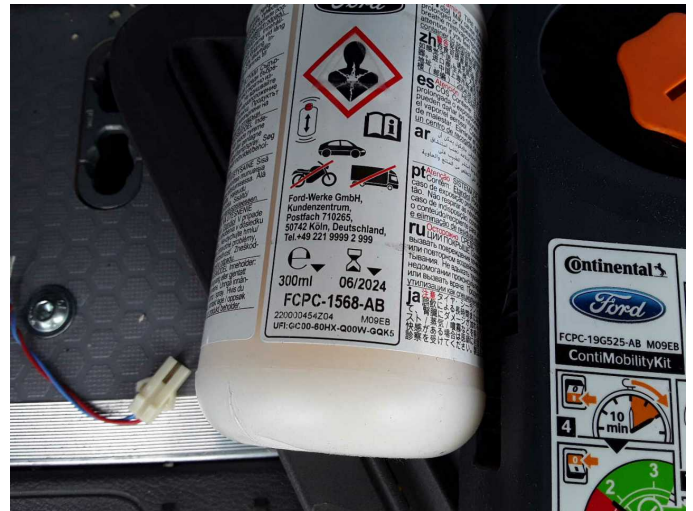
**Damage 1:** Equipment: Tirefit filler - Due - Replace

| No. | Component group | Description |
|---|---|--|
| 1 | Equipment | Tirefit filler - Due - Replace |
