## status report

**customer:** Bank 11, Neuss  
**contract number:** 1010833530  
**reference:**

#### Ford Kuga Cool

| Vehicle identification number | <b>WF0AXXWPMJU61034</b> | mileage read: | <b>60452 km</b> |

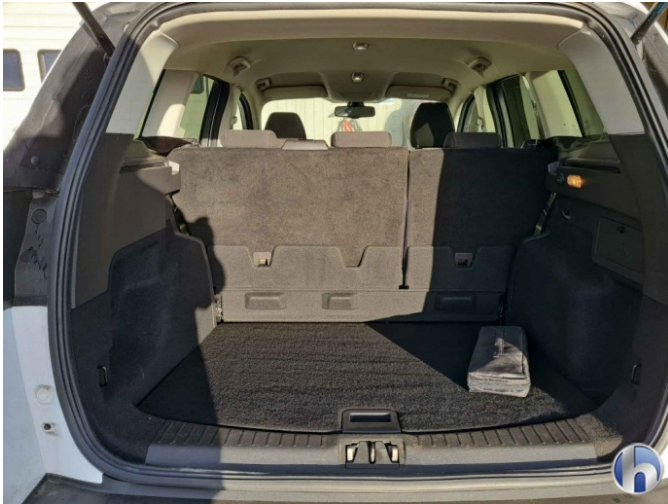
trunk

| | component | Damage | Rep kind |
|---|---|---|---|
| 7. | Laderaumabdeckung | Missing | Replace |

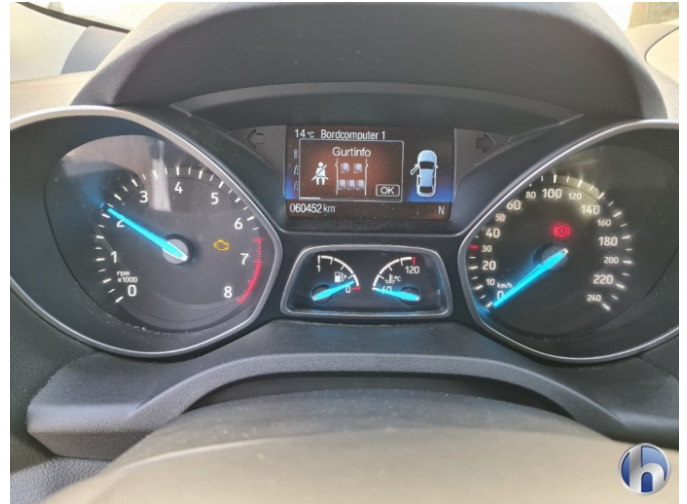
instrument cluster

| Performed testing technology | |
|---|---|
| <b>engine running:</b> | A field test of the engine had to acoustic or visual defects for visiting time .<br>**Engine warning light. Engine run out of round. |

| | component | Damage | Rep kind |
|---|---|---|---|
| 3. | Motor (läuft unrund, geht aus) | Engine damage | Carry out a fault diagnosis |
