Expertise

Protocol number: 41666684
Order No. / Reference: 25228413
Inspection date: 24 Sept 2025

Manufacturer: Ford	Model: Transit 350 L3H2 Lkw VA Trend
VIN: WF0EXXTTREPC35063

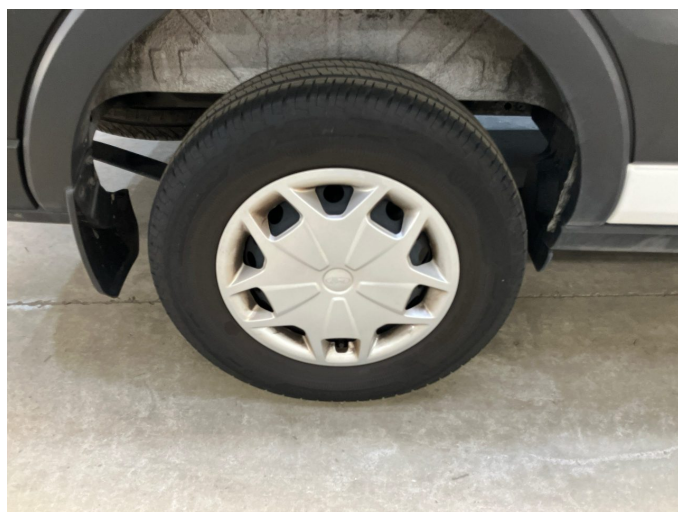
Figure 12: Mounted tyres

#	Tyre size	Type of tyre	Manufacturer	Tread depth
1)	235/65 R16 115R	Summer tyres on Steel rim with wheel cover	Continental	6mm / 6mm
2)	235/65 R16 115R	Summer tyres on Steel rim with wheel cover	Continental	6mm / 6mm

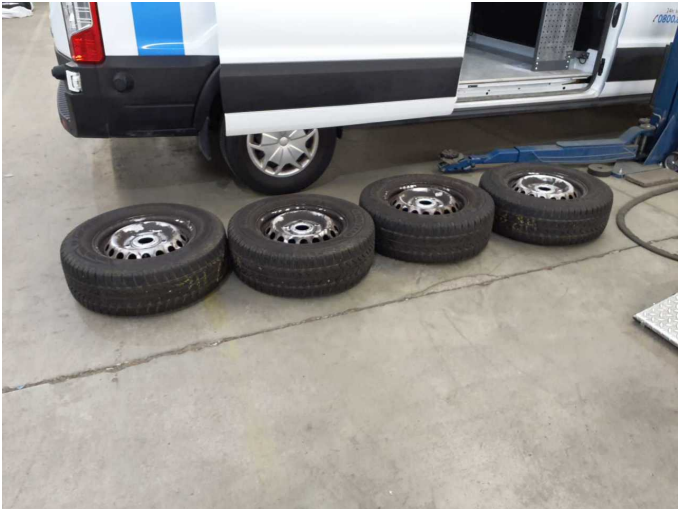
Figure 16: Additional tyres

#	Tyre size	Type of tyre	Manufacturer	Tread depth
1)	235/65 R16 115S	Winter tyres on Steel	Goodyear	6mm / 6mm
2)	235/65 R16 115S	Winter tyres on Steel	Goodyear	6mm / 6mm
