Expertise

Protocol number: 41642388
Order No. / Reference: 25216630
Inspection date: 22 Sept 2025

Manufacturer: Ford

Model: Mondeo Turnier 2.0 EcoBlue Titanium

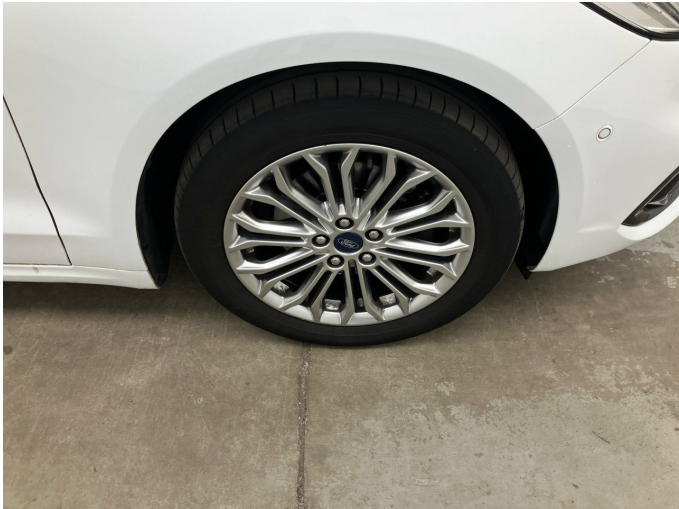
Figure 12: Mounted tyres

#	Tyre size	Type of tyre	Manufacturer	Tread depth
1)	215/55 R17 98W	Summer tyres on Light alloy	Goodyear	3mm / 3mm
2)	215/55 R17 98W	Summer tyres on Light alloy	Goodyear	4mm / 4mm

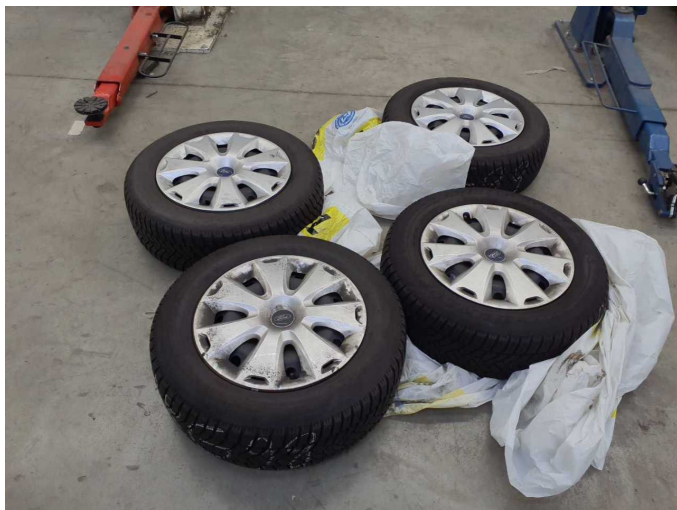
Figure 15: Additional tyres

#	Tyre size	Type of tyre	Manufacturer	Tread depth
1)	215/60 R16 96H	Winter tyres on Steel rim with wheel cover	Dunlop	6mm / 6mm
2)	215/60 R16 96H	Winter tyres on Steel rim with wheel cover	Dunlop	7mm / 7mm
