Expertise

Protocol number: 40807328
Order No. / Reference: 25019778
Inspection date: 28 Jul 2025

Manufacturer: Ford

Model: Focus 1.0 EcoBoost Start-Stopp-System TITANIUM

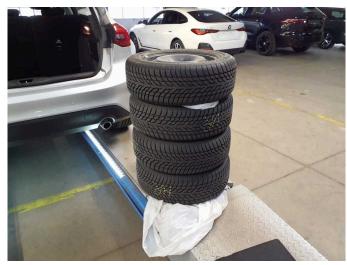
Figure 14: Additional tyres

#	Tyre size	Type of tyre	Manufacture	er	Tread depth
1)	205/60 R16 96H	Winter tyres on Steel	Nokian		7mm / 7mm
2)	205/60 R16 96H	Winter tyres on Steel	Nokian		7mm / 7mm
Rep	lacement				
Тур	Tyre size	Type of tyre	Manufacture	er	Tread depth
N	125/70 R16 92M	Summer tyres on Steel	Hankook		4 mm
