Expertise

Protocol number: 39768565  
Order No. / Reference: 24769021  
Inspection date: 13 May 2025

Manufacturer: Ford

Model: Focus Turnier 1.5 EcoBlue Start-Stopp-System Aut. ACTIVE

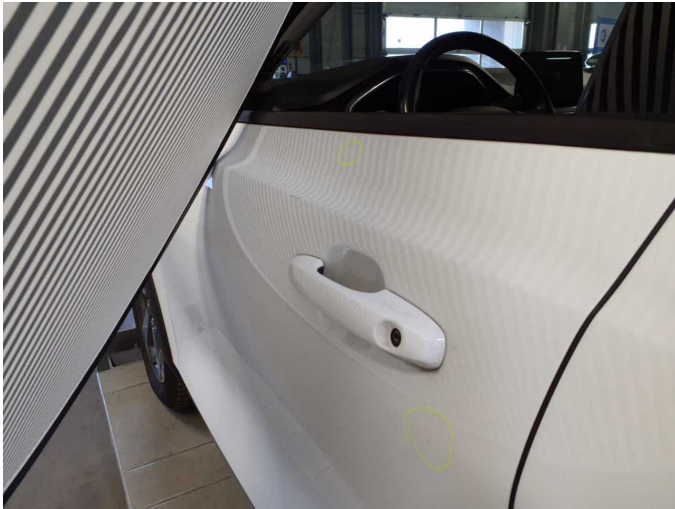
**Damage 12:** Body: Body - Damage by hail - repair according to calculation

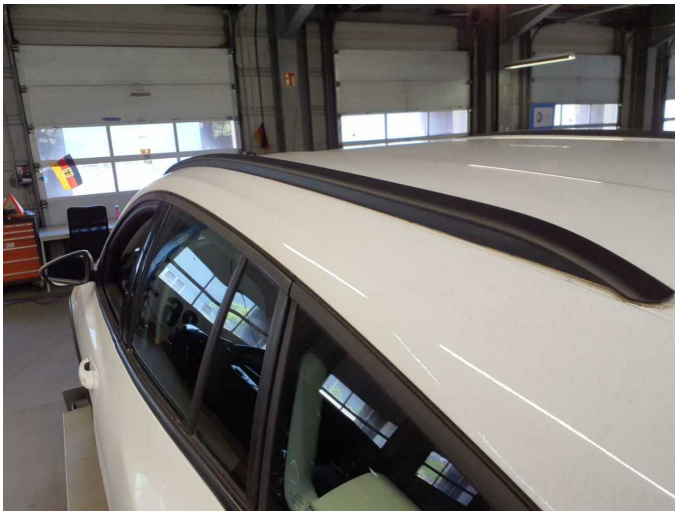
**Accident 1:** Front, Side - left

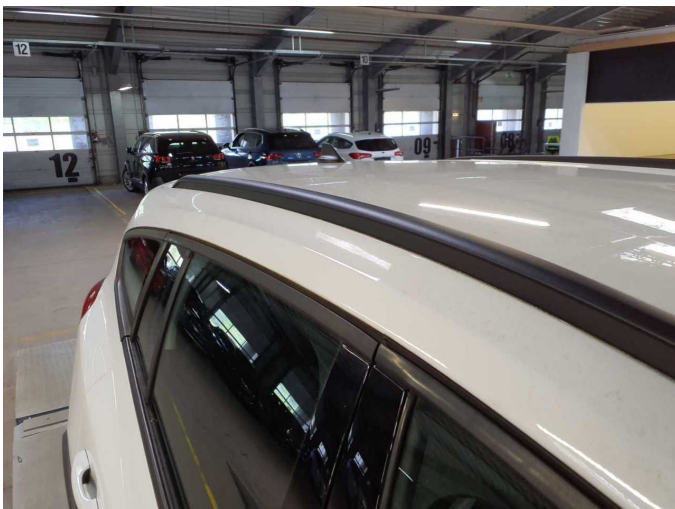
**Repainting 1:** Roof rail - left side

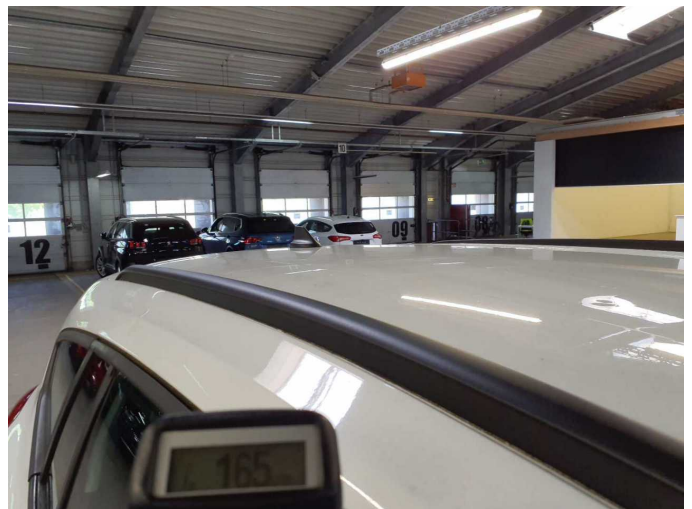
**Repainting 2:** Roof rail - right side

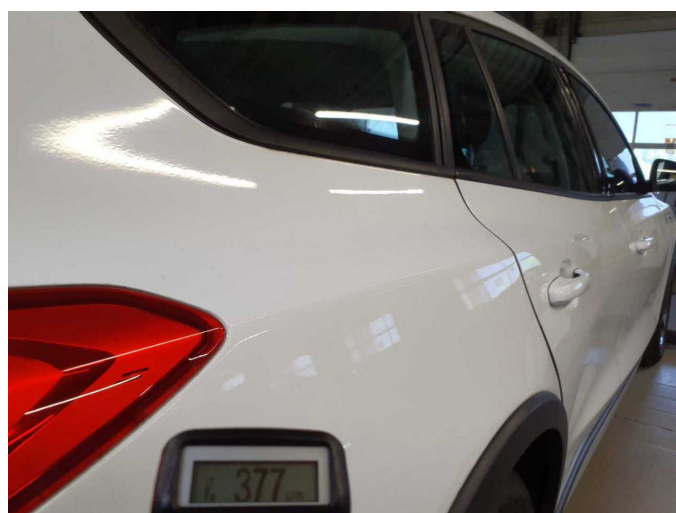
**Repainting 4: Side panel - rear right side**

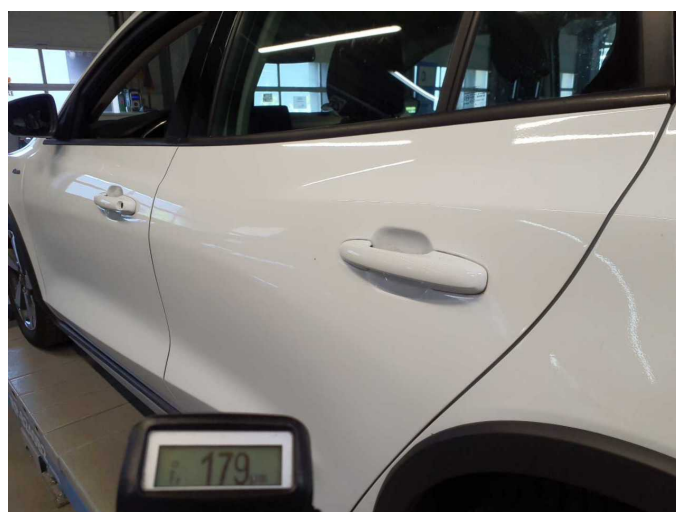
**Repainting 5: Door - rear left side**
