Expertise

Protocol number: 41201849
Order No. / Reference: 25049247
Inspection date: 25 Aug 2025

Model: Focus Turnier 1.5 EcoBlue Start-Stopp-System Aut. TITANIUM

VIN: WF0PXXGCHPLK03408

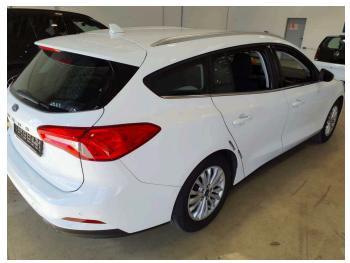
No.	Component group	Description
1	Wing mirror - right side	Cap - Scratch(es) - Smart repair
2	Side panel - rear right side	Side panel - dent(s) - Smooth repair work
3	Roof	Roof - dent(s) - Smart repair
4	Rear bumper	Rear bumper - Scratch(es) - Smart repair
5	Misc.	Inspection / maintenance - Due - Perform

$\label{eq:decomposition} \textbf{Damage 2:} \ \mbox{Side panel - rear right side: Side panel - dent(s) - Smooth repair work}$
