Expertise

Protocol number: 41806384
Order number / reference: 25242393
Inspection date: 2 Oct 2025

Manufacturer: Ford

Model: Focus Turnier 1.5 EcoBlue Start-Stopp-System
COOL&CONNECT

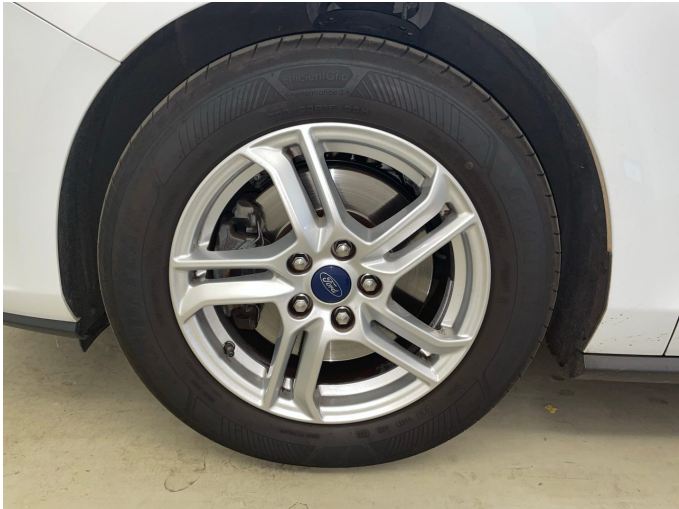
Figure 12: Mounted tyres

#	Tyre size	Type of tyre	Manufacturer	Tread depth
1)	205/60 R16 96H	Summer tyres on Light alloy	Goodyear	7mm / 7mm
2)	205/60 R16 96H	Summer tyres on Light alloy	Goodyear	7mm / 7mm
