## status report

#### Ford Focus Turnier Titanium

| Vehicle identification number | <b>WF0PXXGCHPLL50197</b> | mileage read: | <b>41646 km</b> |

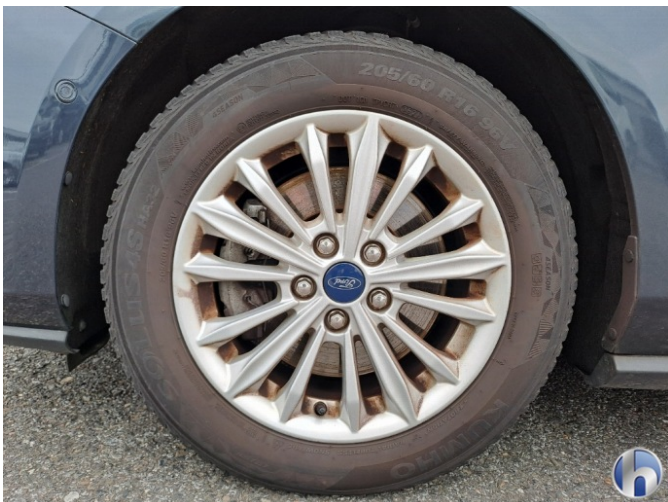
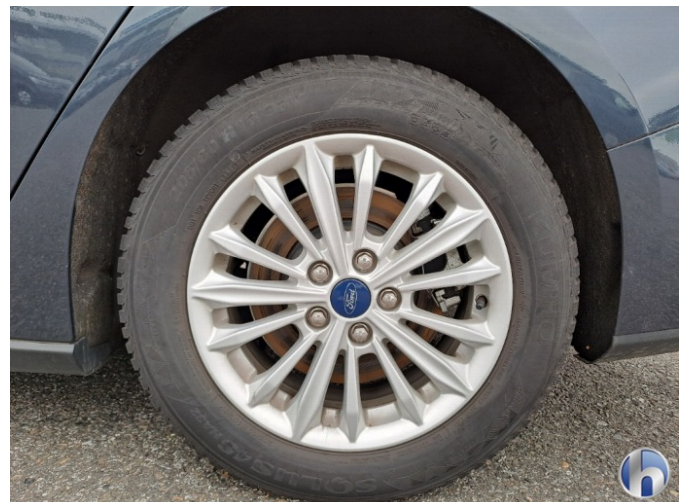
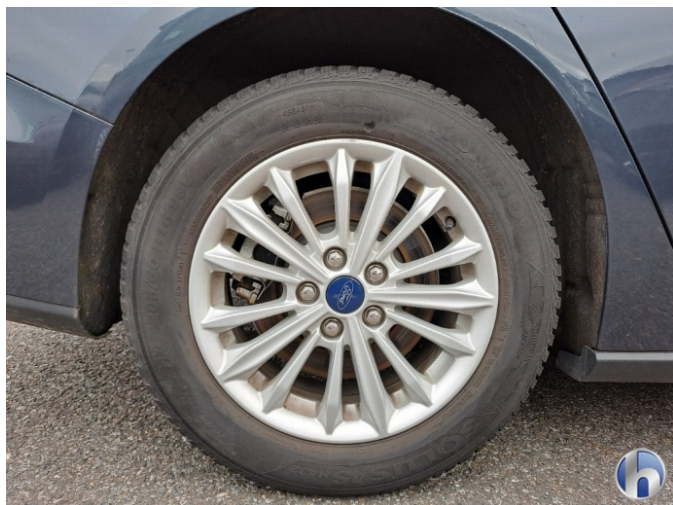
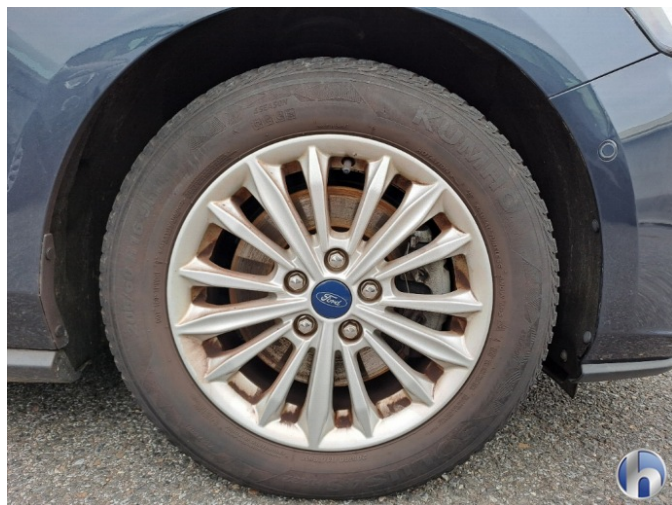
rims

| component | Damage | Rep kind |
|---|---|---|
| 3. Rim rear - right | Damaged | Smart repair |
| 4. tire rear - right | Damaged | Replace |

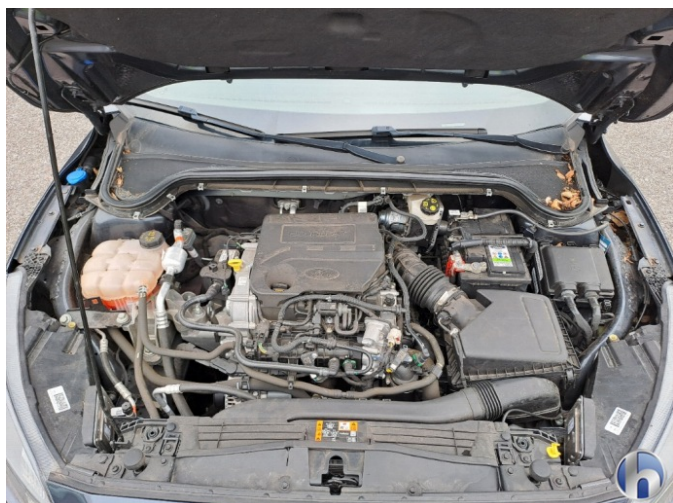
engine compartment

| Performed testing technology | |
|---|---|
| <b>oil loss:</b> | The vehicle could be checked only limited to oil leaks . |
| <b>engine running:</b> | Checking the engine running was limited. Here no audible or visual abnormalities were noted . |
