Expertise

Protocol number: 41458643
Order No. / Reference: 25179421
Inspection date: 9 Sept 2025

Manufacturer: Ford

Model: Focus Turnier 1.5 EcoBlue Start-Stopp-System Aut. TITANIUM
STYLE

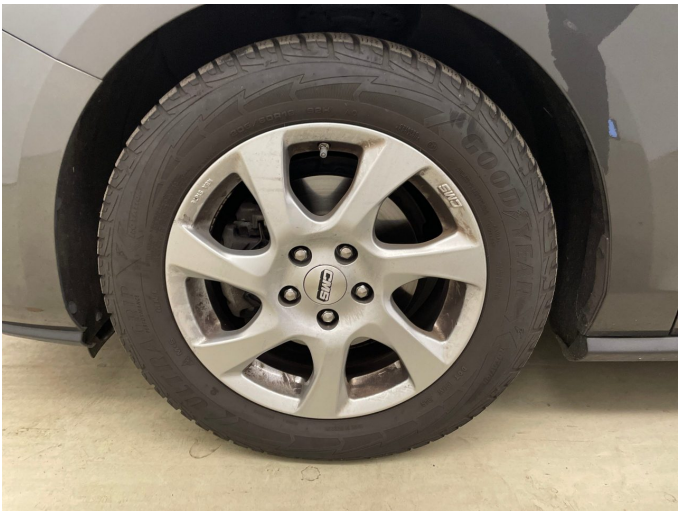
Figure 12: Mounted tyres

#	Tyre size	Type of tyre	Manufacturer	Tread depth
1)	205/60 R16 92H	Winter tyres on Light alloy	Goodyear	3mm / 3mm
2)	205/60 R16 92H	Winter tyres on Light alloy	Goodyear	3mm / 3mm

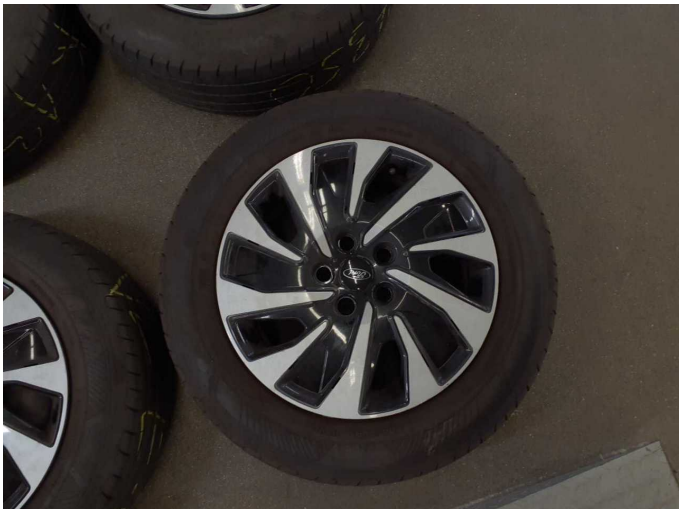
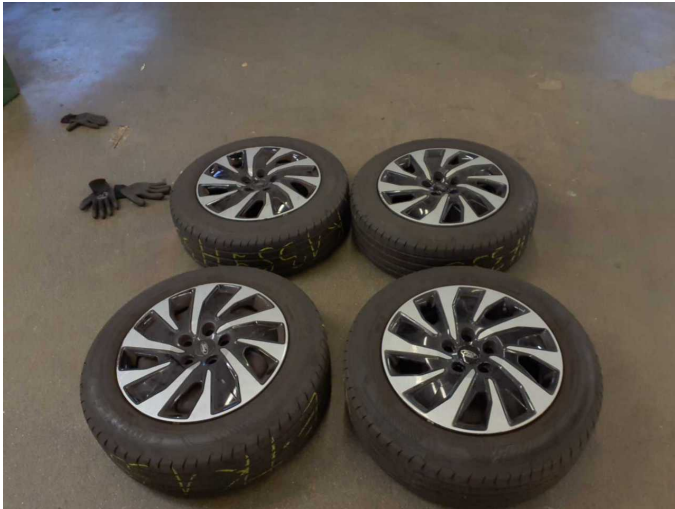
Figure 18: Additional tyres

#	Tyre size	Type of tyre	Manufacturer	Tread depth
1)	205/60 R16 96W	Summer tyres on Steel rim with wheel cover	Goodyear	6mm / 6mm
2)	205/60 R16 96W	Summer tyres on Steel rim with wheel cover	Goodyear	6mm / 6mm
