FORD TRANSIT (30)
TRANSIT CUSTOM FOURGON 280 L1H1 2.0
ECOBBLUE 110 CH TREND

VIN NO WF0RXXTA1RRA42413
Registration Number GX922QL

Inspection Report Summary

| Customer | BCAuto Encheres | Report Number | P20250902141151 |

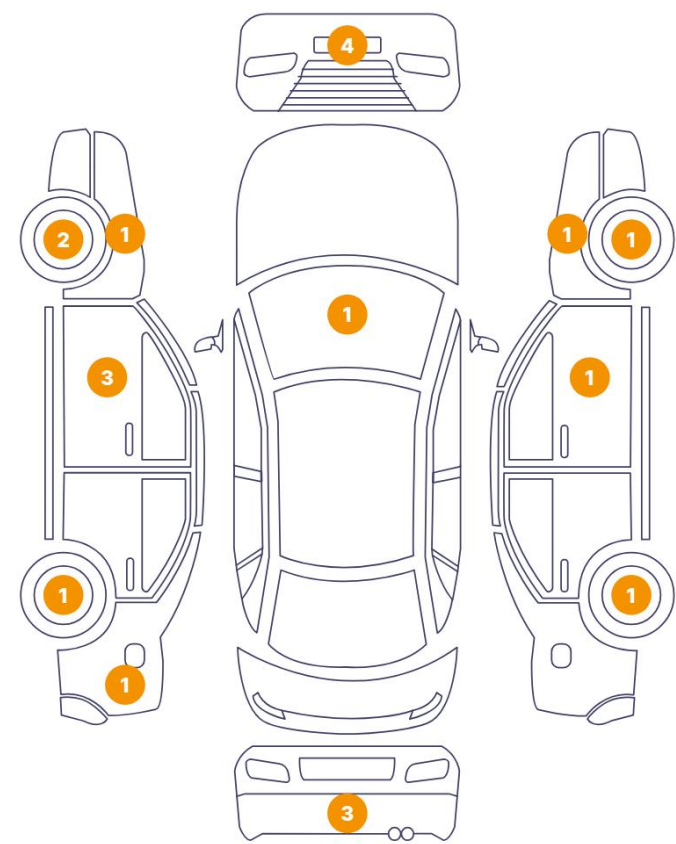
20 Dommages

| Component | | Damage | Comments |
|---|---|---|---|
| 1 | Panel Filling / Front Left | Interior / Dirty | |
| 3 | Seat Cushion / Front Left | Interior / Stained | |
| 5 | Trunk Carpet | Interior / Stained | |

| 18 | Mirror Glass / Front Left | Missing Part |
| 26 | Hubcap / Back Right | Missing element hubcap |
