Expertise

Protocol number: 41618344
Order No. / Reference: 25133157
Inspection date: 18 Sept 2025

Manufacturer: Ford

Model: Transit Connect 240 L2 S&S Trend

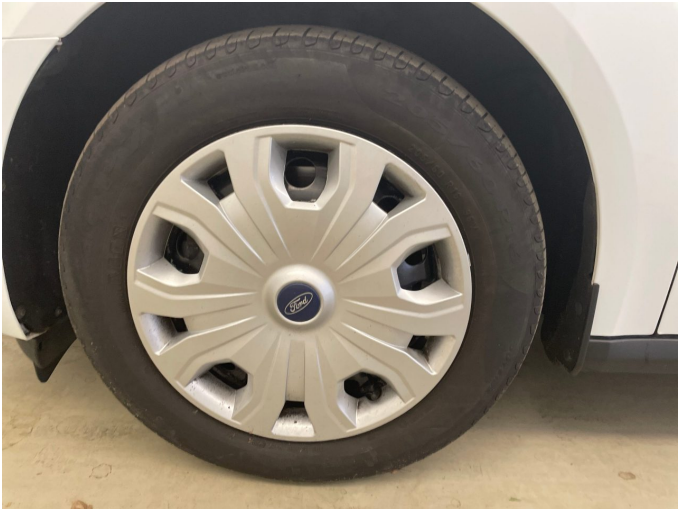
Figure 12: Mounted tyres

#	Tyre size	Type of tyre	Manufacturer	Tread depth
1)	205/60 R16 96V	Summer tyres on Steel rim with wheel cover	Pirelli	5mm / 5mm
2)	205/60 R16 96V	Summer tyres on Steel rim with wheel cover	Pirelli	7mm / 7mm
