Expertise

Protocol number: 41343510
Order No. / Reference: 25155480
Inspection date: 2 Sept 2025

Manufacturer: Ford

Model: Transit Connect 240 L2 S&S Trend

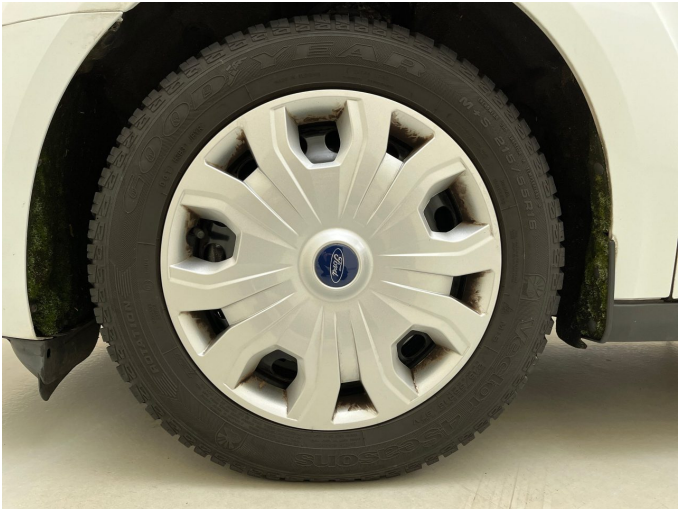
Figure 12: Mounted tyres

#	Tyre size	Type of tyre	Manufacturer	Tread depth
1)	215/55 R16 97V	All-season tyres on Steel rim with wheel cover	Goodyear	6mm / 6mm
2)	215/55 R16 97V	All-season tyres on Steel rim with wheel cover	Goodyear	8mm / 8mm
