## status report

**customer:** BCA Autoauktionen GmbH

#### Ford Transit Custom Kasten 290 L1 Sport

| Vehicle identification number | <b>WF0YXXTTGYKP54683</b> | mileage read: | <b>114595 km</b> |

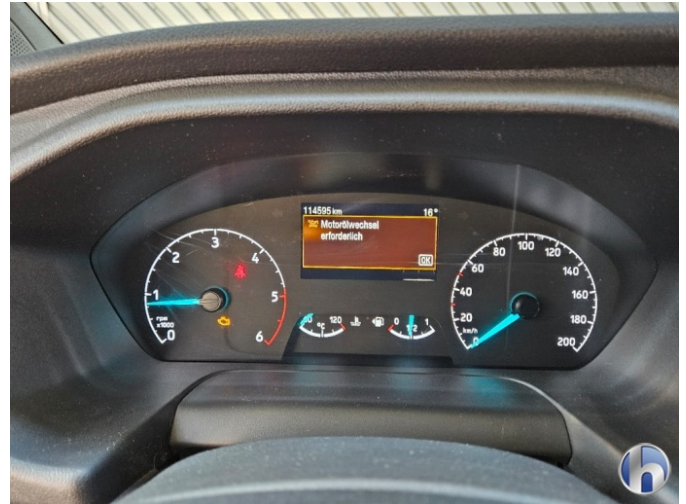
instrument cluster

| Performed testing technology | |
|---|---|
| <b>engine running:</b> | A field test of the engine had to acoustic or visual defects for visiting time .<br>**Engine warning light. |
