Expertise

Protocol number: 41615691
Order No. / Reference: 25179341
Inspection date: 19 Sept 2025

Manufacturer: Ford	Model: Transit Custom Kasten 300 L1H1 LKW VA Trend
VIN: WF0YXXTTGYLR07089

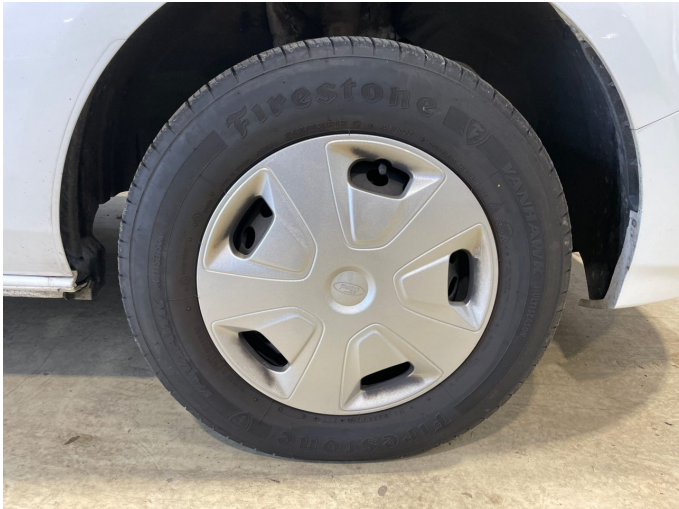
#	Tyre size	Type of tyre	Manufacturer	Tread depth
1)	215/65 R15 104T	All-season tyres on Steel rim with wheel cover	Firestone	6mm / 6mm
2)	215/65 R15 104T	All-season tyres on Steel rim with wheel cover	Firestone	7mm / 7mm

Figure 12: Mounted tyres
