Expertise

Protocol number: 41642732
Order No. / Reference: 25252059
Inspection date: 19 Sept 2025

Manufacturer: Ford

Model: Transit Custom 280 L1H1 LKW VA Trend

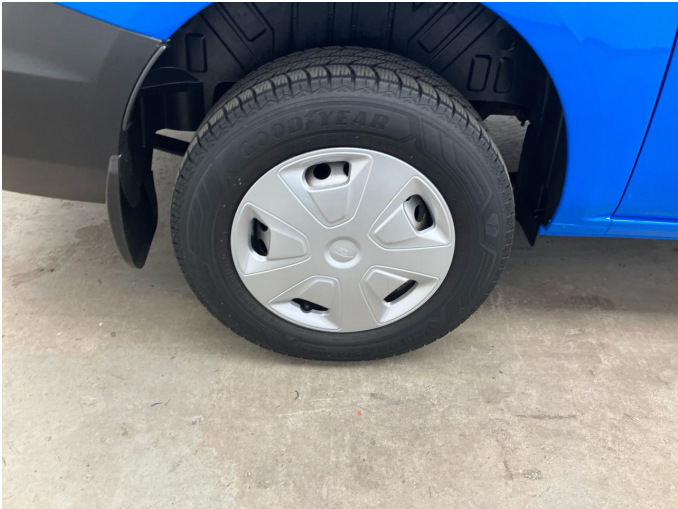
Figure 12: Mounted tyres

Mounted tyres				
#	Tyre size	Type of tyre	Manufacturer	Tread depth
1)	215/65 R15 104T	All-season tyres on Steel rim with wheel cover	Continental	6mm / 6mm
2)	215/65 R15 104T	All-season tyres on Steel rim with wheel cover	Continental	6mm / 6mm
