Expertise

Protocol number: 41678697
Order No. / Reference: 25228393
Inspection date: 24 Sept 2025

Manufacturer: Ford	Model: Transit Custom 300 L2H1 LKW VA Trend
VIN: WF0YXXTTGYNA83678

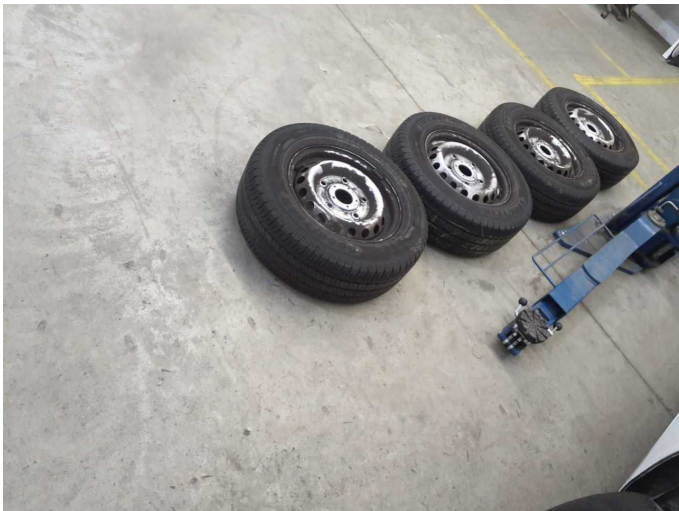
Figure 16: Additional tyres

- Winterradsatz ist kein Bestandteil des Auslieferumfangs.
- Für den montierten Radsatz wurde kein Nachweiß erbracht.
