Expertise

Protocol number: 41631286
Order No. / Reference: 25196447
Inspection date: 19 Sept 2025

Manufacturer: Ford	Model: Transit Custom 300 L2H1 LKW VA Trend
VIN: WF0YXXTTGYNG28326

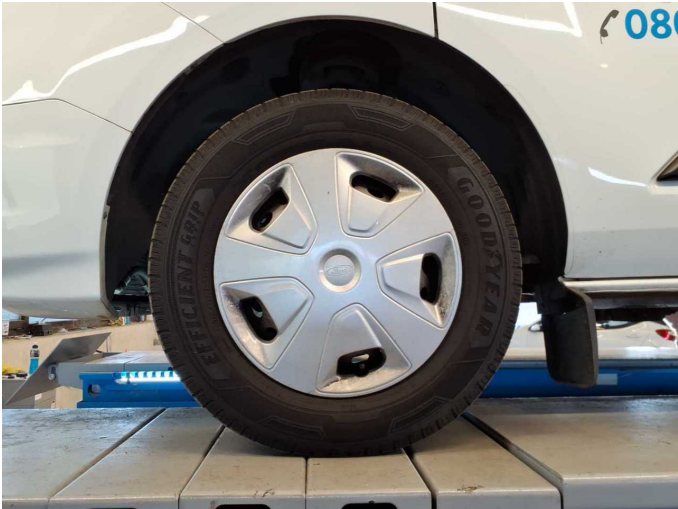
Figure 12: Mounted tyres

#	Tyre size	Type of tyre	Manufacturer	Tread depth
1)	215/65 R15 104T	Summer tyres on Steel rim with wheel cover	Goodyear	5mm / 5mm
2)	215/65 R15 104T	Summer tyres on Steel rim with wheel cover	Goodyear	5mm / 5mm

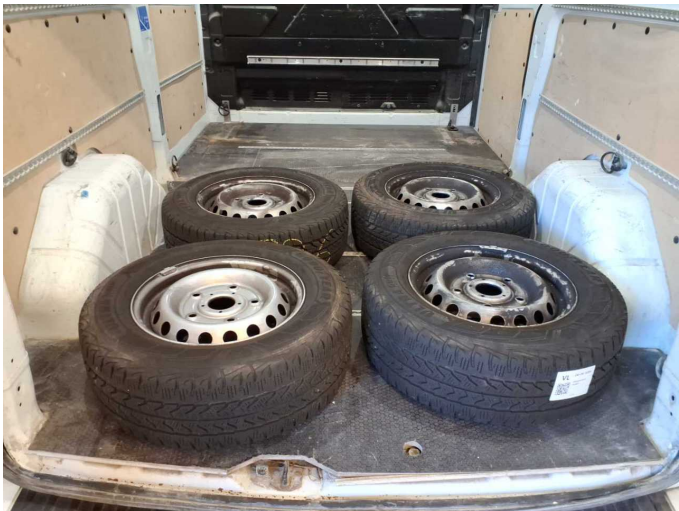
Figure 14: Additional tyres

#	Tyre size	Type of tyre	Manufacturer	Tread depth
1)	215/65 R15 104T	Winter tyres on Steel	Goodyear	5mm / 5mm
2)	215/65 R15 104T	Winter tyres on Steel	Goodyear	5mm / 5mm
