## status report

**customer:** Bank 11, Neuss  
**contract number:**  
**reference:**

#### Smart fortwo cabrio Basis 52 kW

| Vehicle identification number | <b>WME4534421K133139</b> | mileage read: | <b>57570 km</b> |

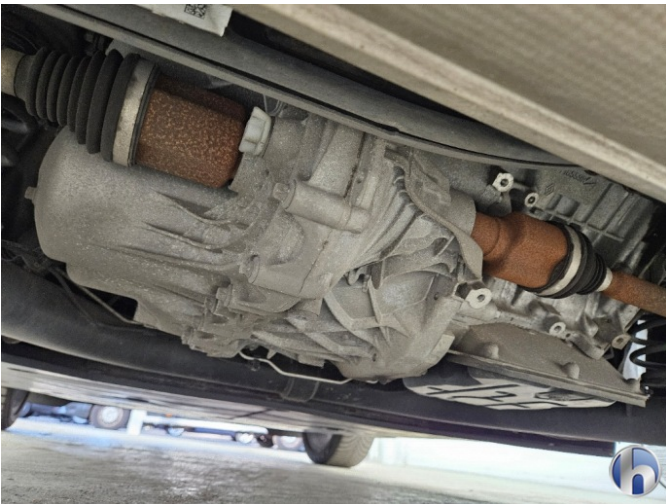
engine compartment

| Performed testing technology | |
|---|---|
| <b>engine running:</b> | Checking the engine running was limited. Here no audible or visual abnormalities were noted . |
