Expertise

Protocol number: 41634455  
Order No. / Reference: 25254742  
Inspection date: 19 Sept 2025

| Manufacturer: Volkswagen | Model: Caddy 2.0 TDI Maxi EcoProfi |
| VIN: WV1ZZZ2KZLX117237 | |

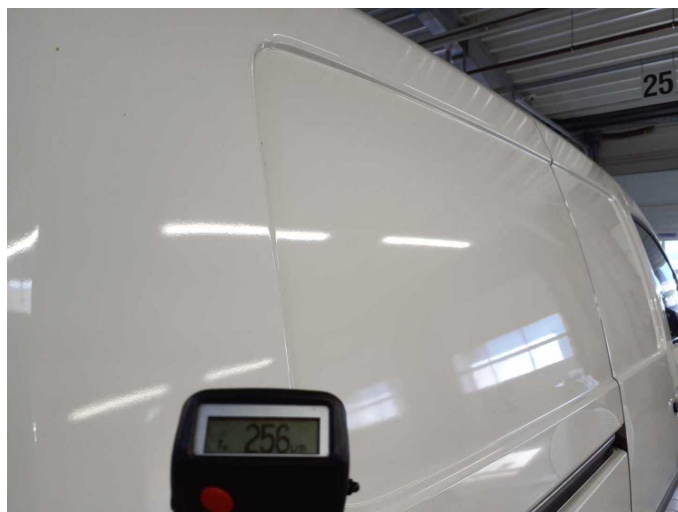
- Side panel - rear right side, Invoice of repair done Non-existent

**Repainting 1:** Side panel - rear right side
