Expertise

Protocol number: 40923598  
Order No. / Reference: 25055944  
Inspection date: 5 Aug 2025

Manufacturer: Volkswagen

Model: Transporter T6 Kurz BlueMotion

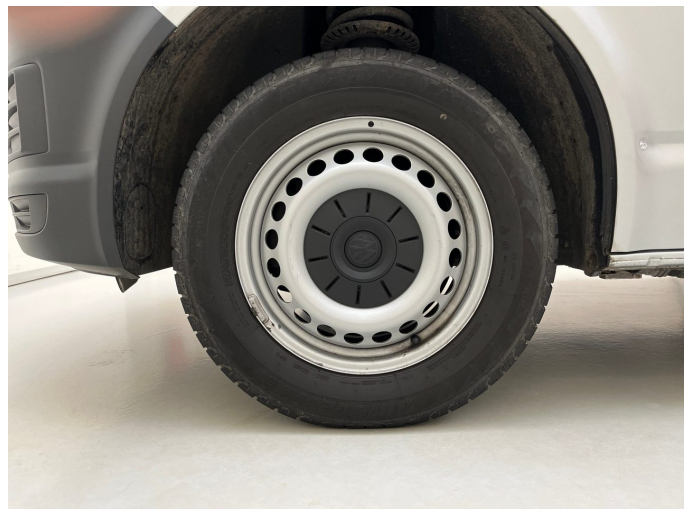
Figure 12: Mounted tyres

#	Tyre size	Type of tyre	Manufacturer	Tread depth
1)	215/65 R16 106T	Winter tyres on Steel rim with wheel cover	Bridgestone	6mm / 5mm
2)	215/65 R16 106T	Winter tyres on Steel rim with wheel cover	Bridgestone	4mm / 3mm

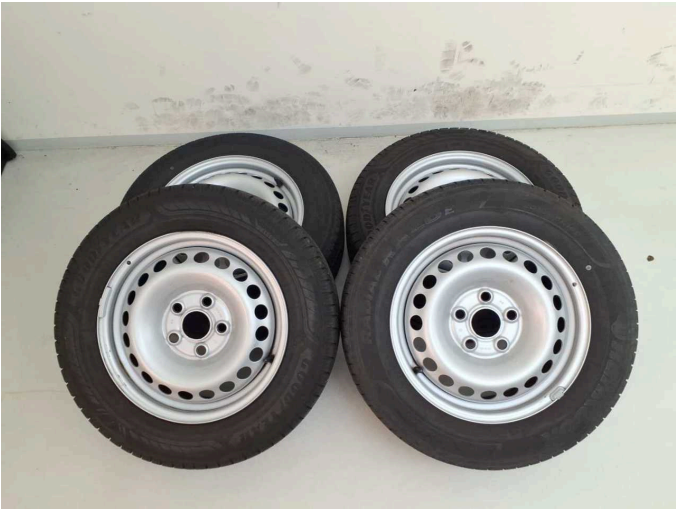
Figure 17: Additional tyres

#	Tyre size	Type of tyre	Manufacturer	Tread depth
1)	205/65 R16 107T	Summer tyres on Steel	Goodyear	8mm / 8mm
2)	205/65 R16 107T	Summer tyres on Steel	unterschiedliche Hersteller	8mm / 7mm
