## status report

#### Volkswagen Crafter Kasten Kasten 35 lang Hochdach FWD

| Vehicle identification number | <b>WV1ZZZSYZK9054523</b> | mileage read: | <b>165978 km</b> |

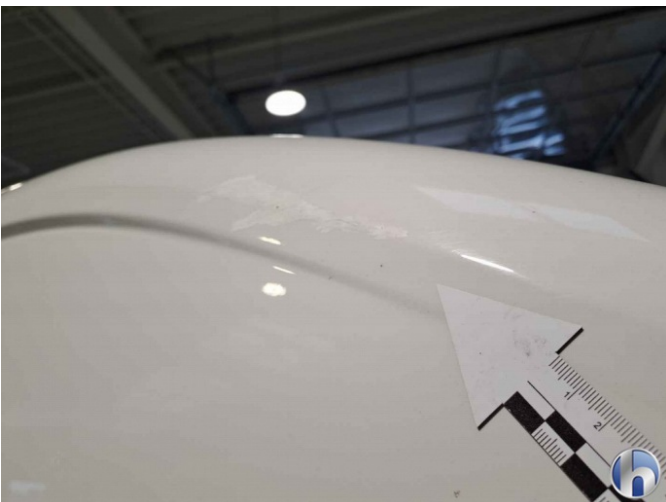
| component | Damage | Rep kind |
|---|---|---|
| 21. Roof frame - right | Execution defect | Smart repair |

21. Roof frame - right
