Expertise

Protocol number: 41209143
Order No. / Reference: 25101293
Inspection date: 24 Aug 2025

Manufacturer: Volkswagen Model: Crafter 35 TDI VA

VIN: WV1ZZZSYZM9030617

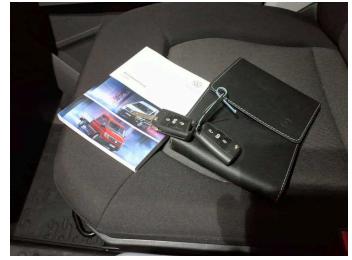
Figure 13: Documents

Brief expert findings	
Documents submitted	At the time of the inspection, the registration certificate Part 2 (letter) was available, but the registration certificate
	Part 1 (certificate) was not. (Copy)
VIN comparison	The vehicle identification number (VIN) was read from the vehicle and its conformity with the submitted
	documents was verified during the inspection by the undersigned.
Inspection	The inspection conditions were sufficient for the assessment of the vehicle.
	Lifting equipment and a pit were available for examining the vehicle.
Test drive	No test drive/maneuvering was carried out during the inspection of the vehicle.
Engine function test	An engine test run was performed.

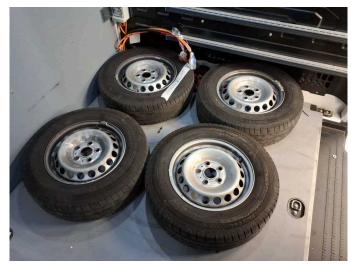
Figure 14: Additional tyres

#	Tyre size	Type of tyre	Manufacture	er	Tread depth	
1)	205/75 R16 113R	All-season tyres on Steel	Continental		2mm / 3mm	
2)	205/75 R16 113R	All-season tyres on Steel	Continental		3mm / 4mm	
Rep	lacement					
Тур	Tyre size	Type of tyre	Manufacture	er	Tread depth
