VOLKSWAGEN Touran

Touran 1.6 TDI DPF

VIN NO WVGZZZ1TZDW061354
Registration Number TZDW061354

Inspection Report Summary

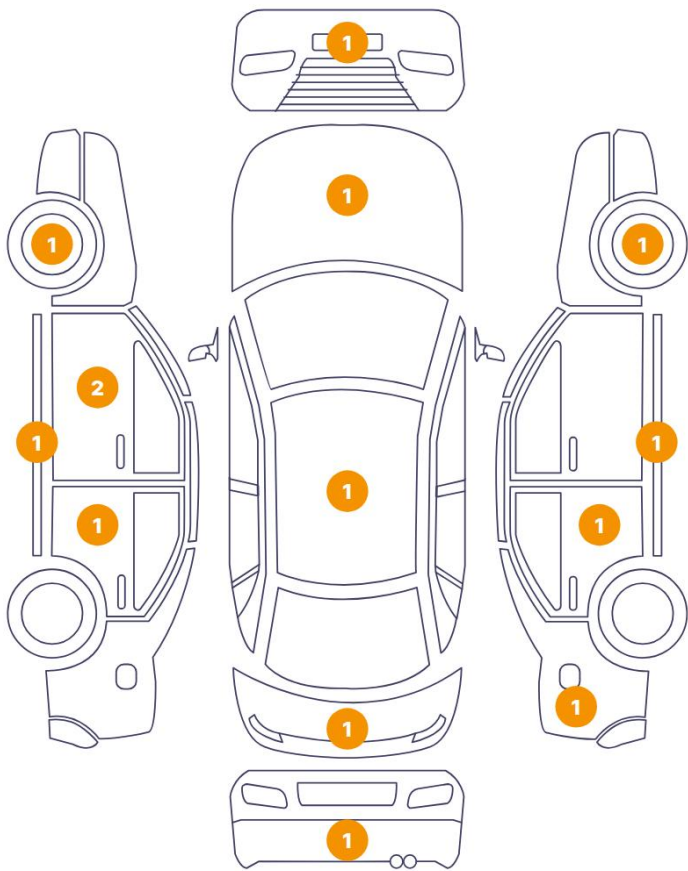
14 Schäden

Component		Damage	Comments
1	Tailgate	Paint / Poor Previous Repair	
2	Roof	Bodywork / Dent / Dent	
3	Side Panel / Back Right	Bodywork / Dent / Dent	
4	Hood	Paint / Scratch / Scuff	
5	Rim / Front Left	Out of Bodywork / Scratch	
6	Door / Front Left	Paint / Corrosion	
7	Rocker Panel / Center Left	Paint / Corrosion	
8	Door / Front Left	Paint / Scratch / Scuff	
9	Pillar / Back Left	Bodywork / Dent / Dent	
10	Bumper / Back	Paint / Scratch / Scuff	
11	Pillar / Back Right	Bodywork / Dent / Dent	
12	Seat / Front Right	Interior / Dirty

13	Rocker Panel / Center Right	Paint / Corrosion
14	Rim / Front Right	Out of Bodywork / Scratch
15	Bumper / Front	Paint / Stone Chip
