## status report

#### Volkswagen Touran Comfortline BMT/Start-Stopp

| Vehicle identification number | <b>WVGZZZ1TZLW021842</b> | mileage read: | <b>216114 km</b> |

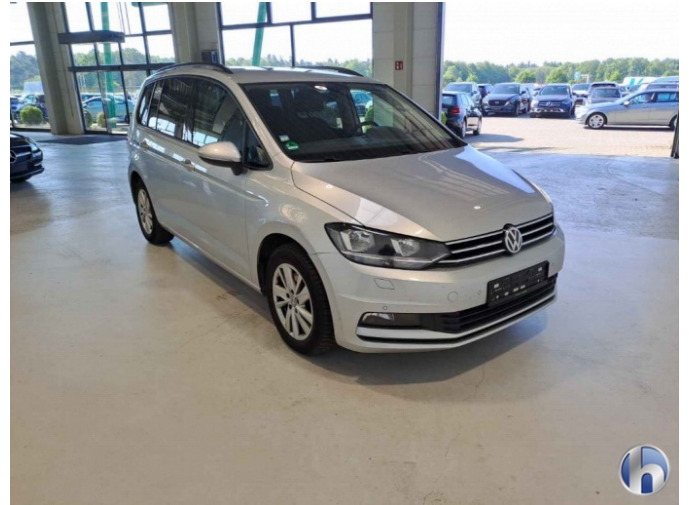
front Right

| Performed testing technology | |
|---|---|
| <b>reference:</b> | *Fahrzeug hat Alter und Laufleistungs bedingte Gebrauchsspuren innen und außen Unfallschaden Stoßfänger vorne rechts, Kotflügel VR Schaden und Kosten Erweiterung möglich |
